## Tank Inspection Report

Client	<b>Sample</b>
Location	<b>Sample</b>
Tank Identification	<b>Tank 8</b>
Inspection Date	<b>Sample</b>

## Results Summary – Tank 8

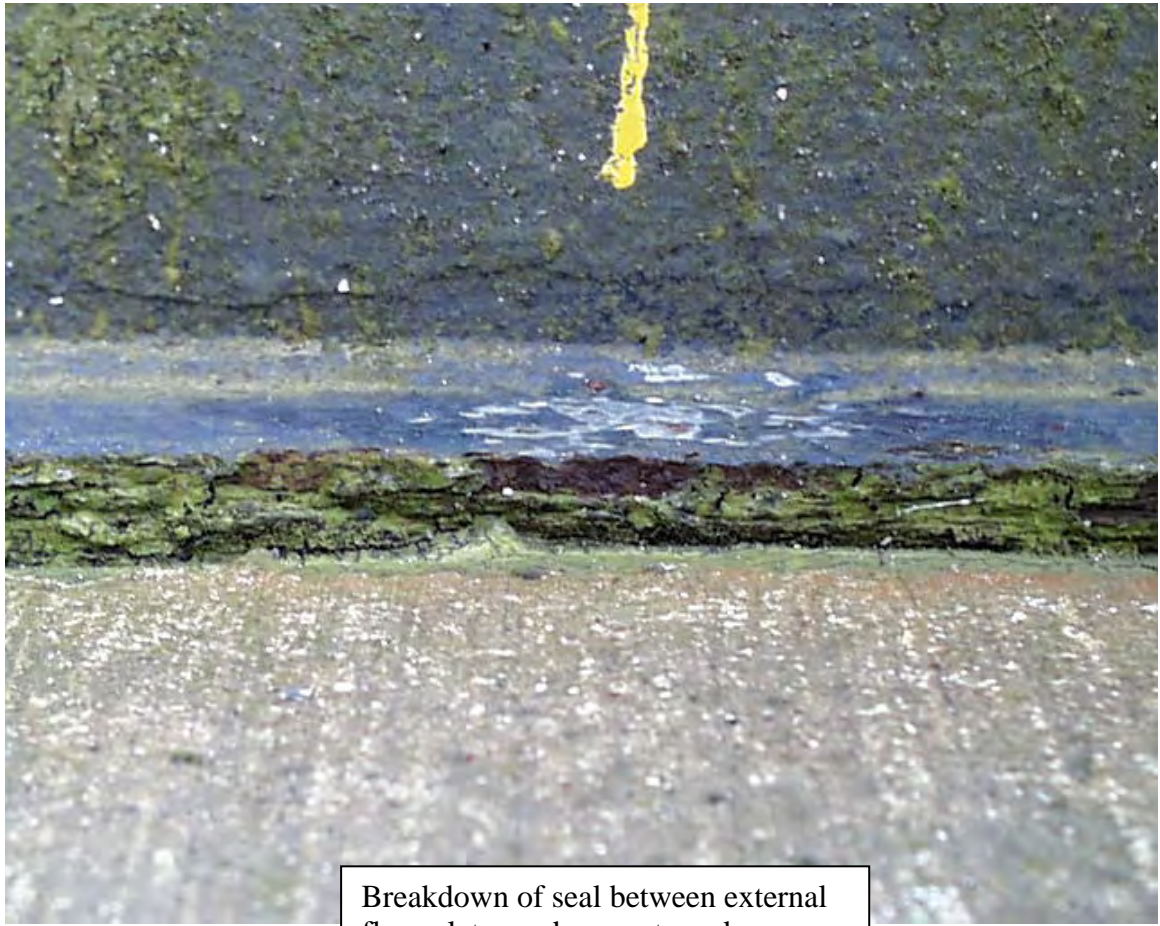
External Tank Floor Plates (Toe)

Breakdown of seal between external floor plates and concrete pad resulting in minor corrosion to the external floor plates in several areas

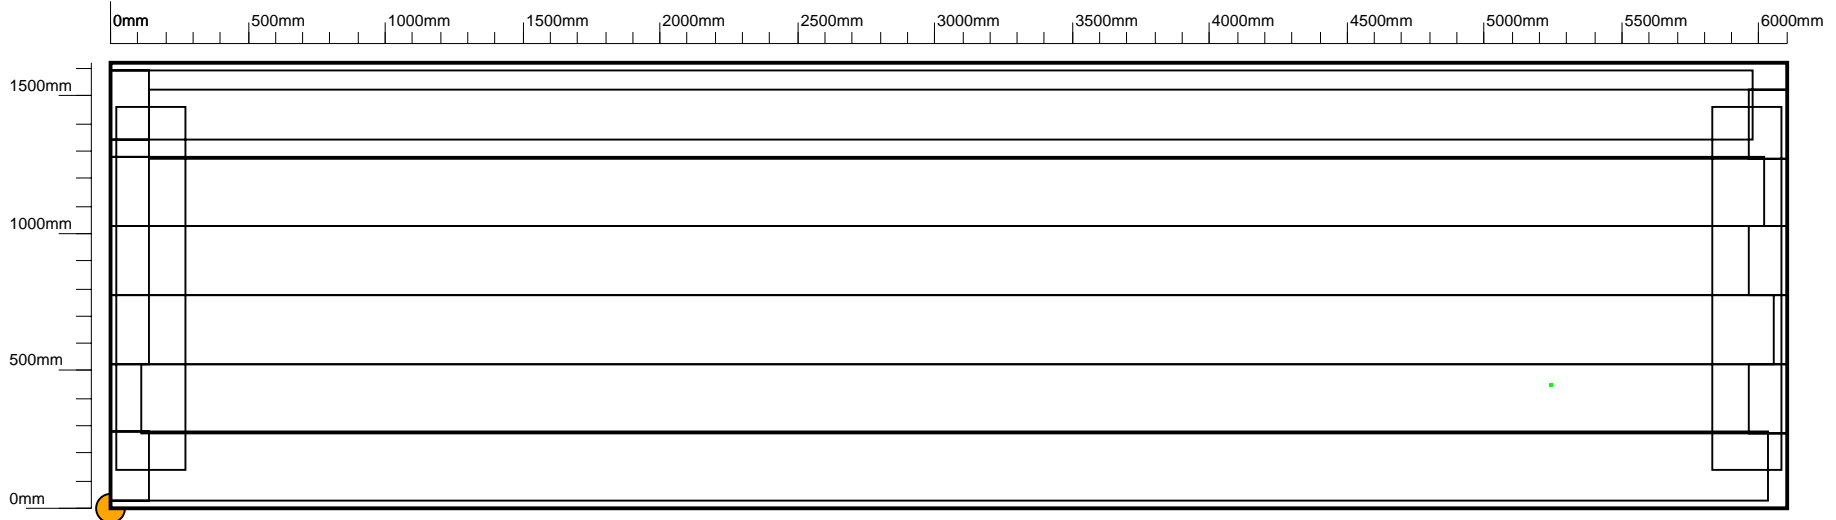
**Row:** 2  
**Plate Length:** 6100  
**Orientation:** Horizontal  
**Max discontinuity:** 44  
**Lower Threshold:** 40

**Plate:** 2  
**Plate Width:** 1620  
**Scan Method:** Raster  
**Discontinuity Count:** 1  
**Upper Threshold:** 100

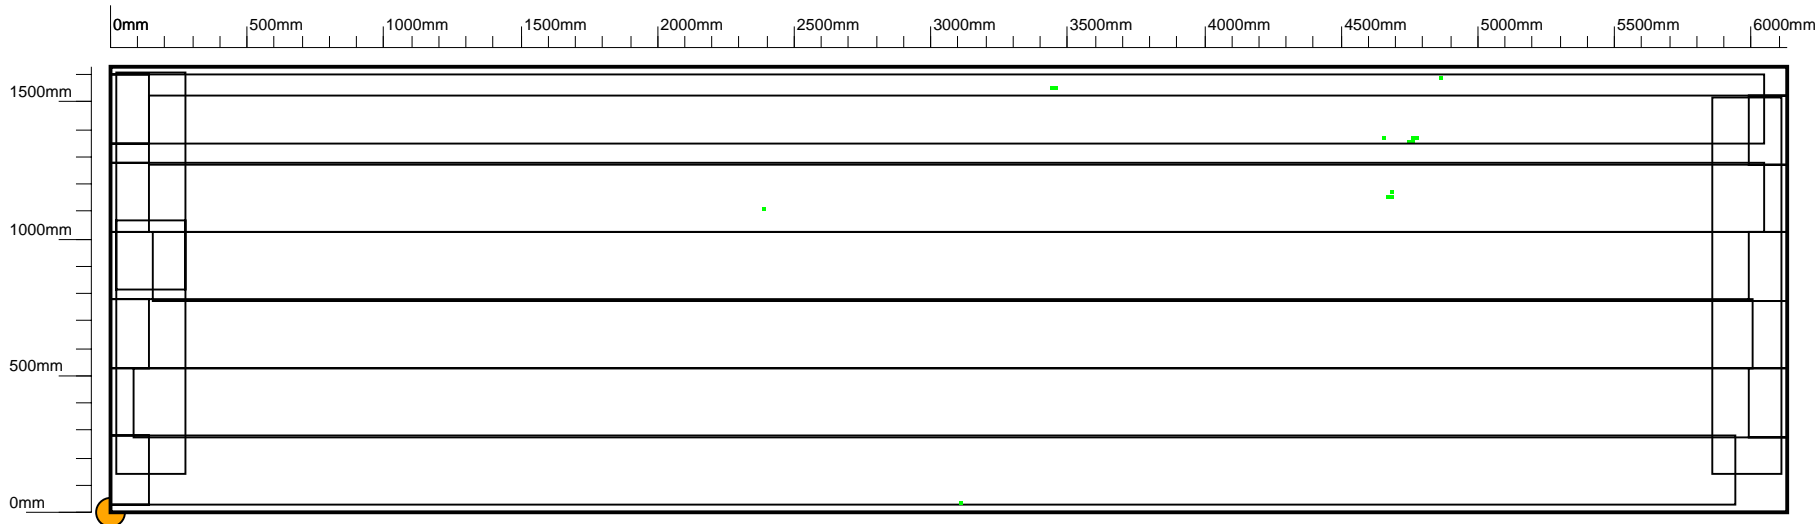
**Row:** 3  
**Plate Length:** 6130  
**Orientation:** Horizontal  
**Max discontinuity:** 48  
**Lower Threshold:** 40

**Plate:** 3  
**Plate Width:** 1630  
**Scan Method:** Raster  
**Discontinuity Count:** 13  
**Upper Threshold:** 100

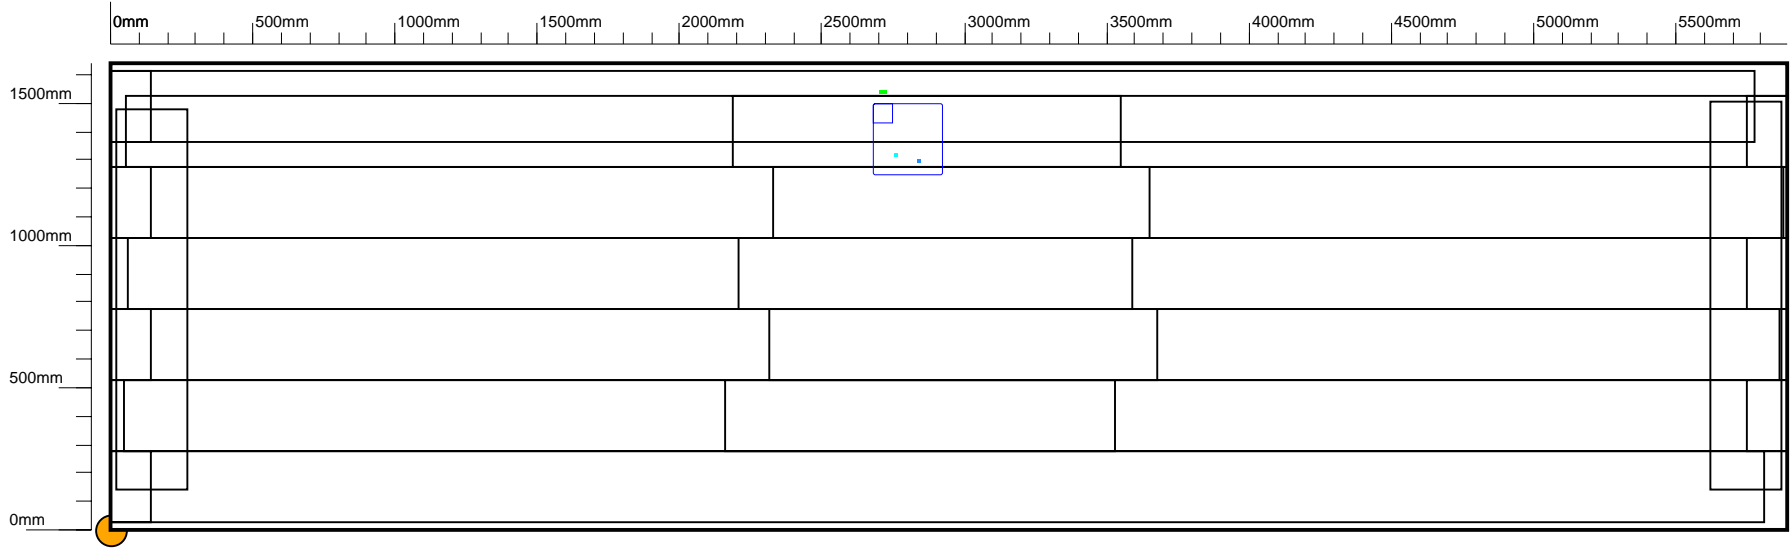
**Row:** 7  
**Plate Length:** 5890  
**Orientation:** Horizontal  
**Max discontinuity:** 60  
**Lower Threshold:** 40

**Plate:** 4  
**Plate Width:** 1640  
**Scan Method:** Raster  
**Discontinuity Count:** 4  
**Upper Threshold:** 100

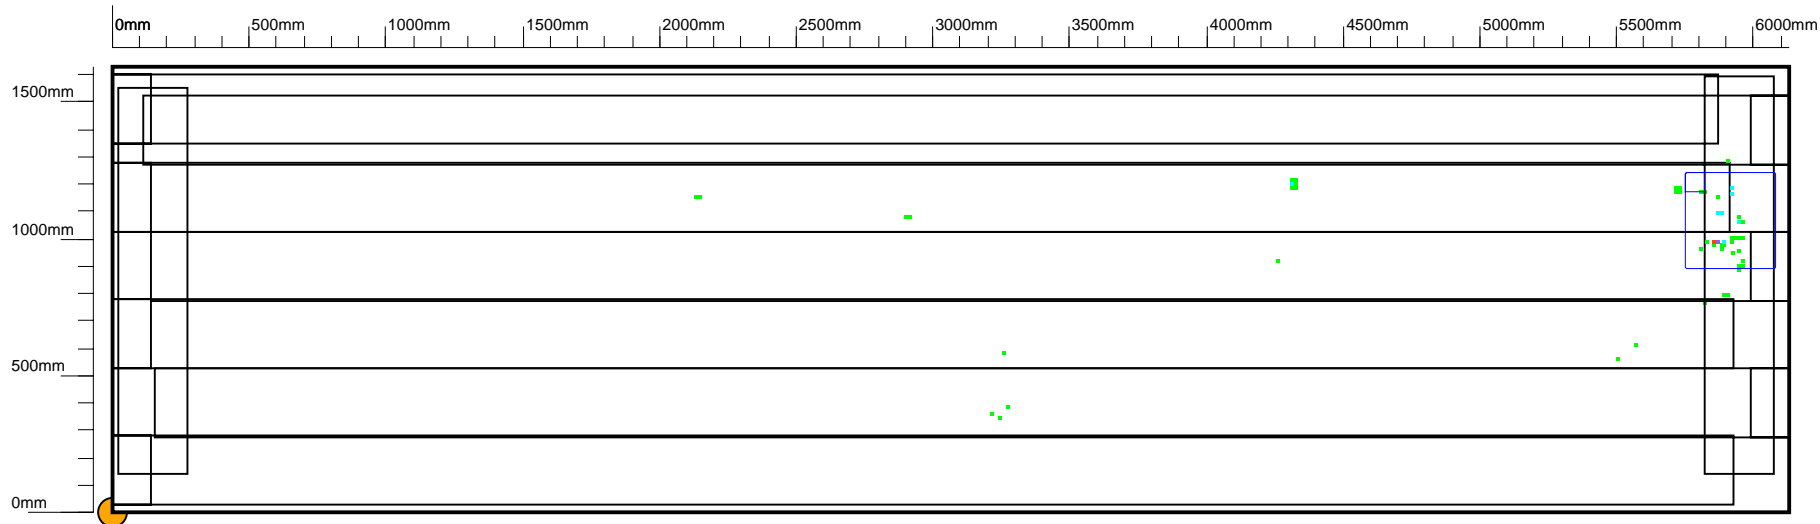
**Row:** 15  
**Plate Length:** 6130  
**Orientation:** Horizontal  
**Max discontinuity:** 80  
**Lower Threshold:** 40

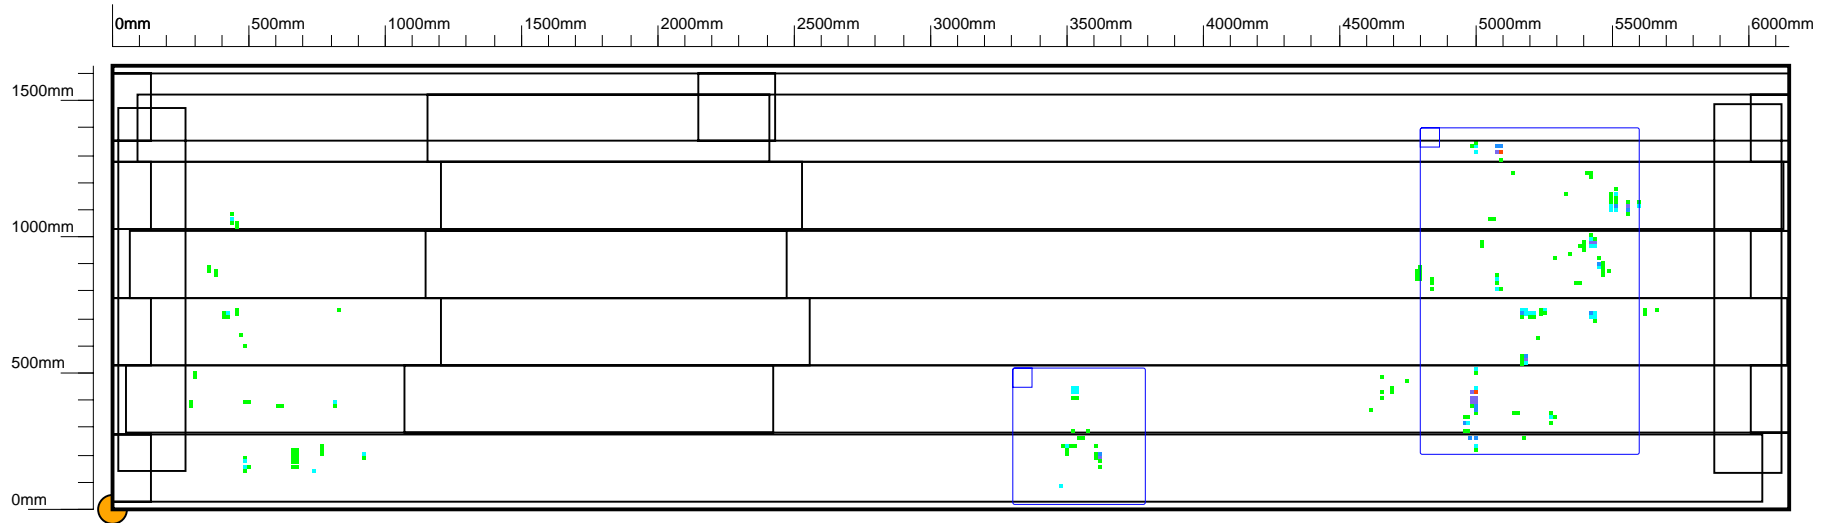
**Row:** 16  
**Plate Length:** 6150  
**Orientation:** Horizontal  
**Max discontinuity:** 80  
**Lower Threshold:** 40

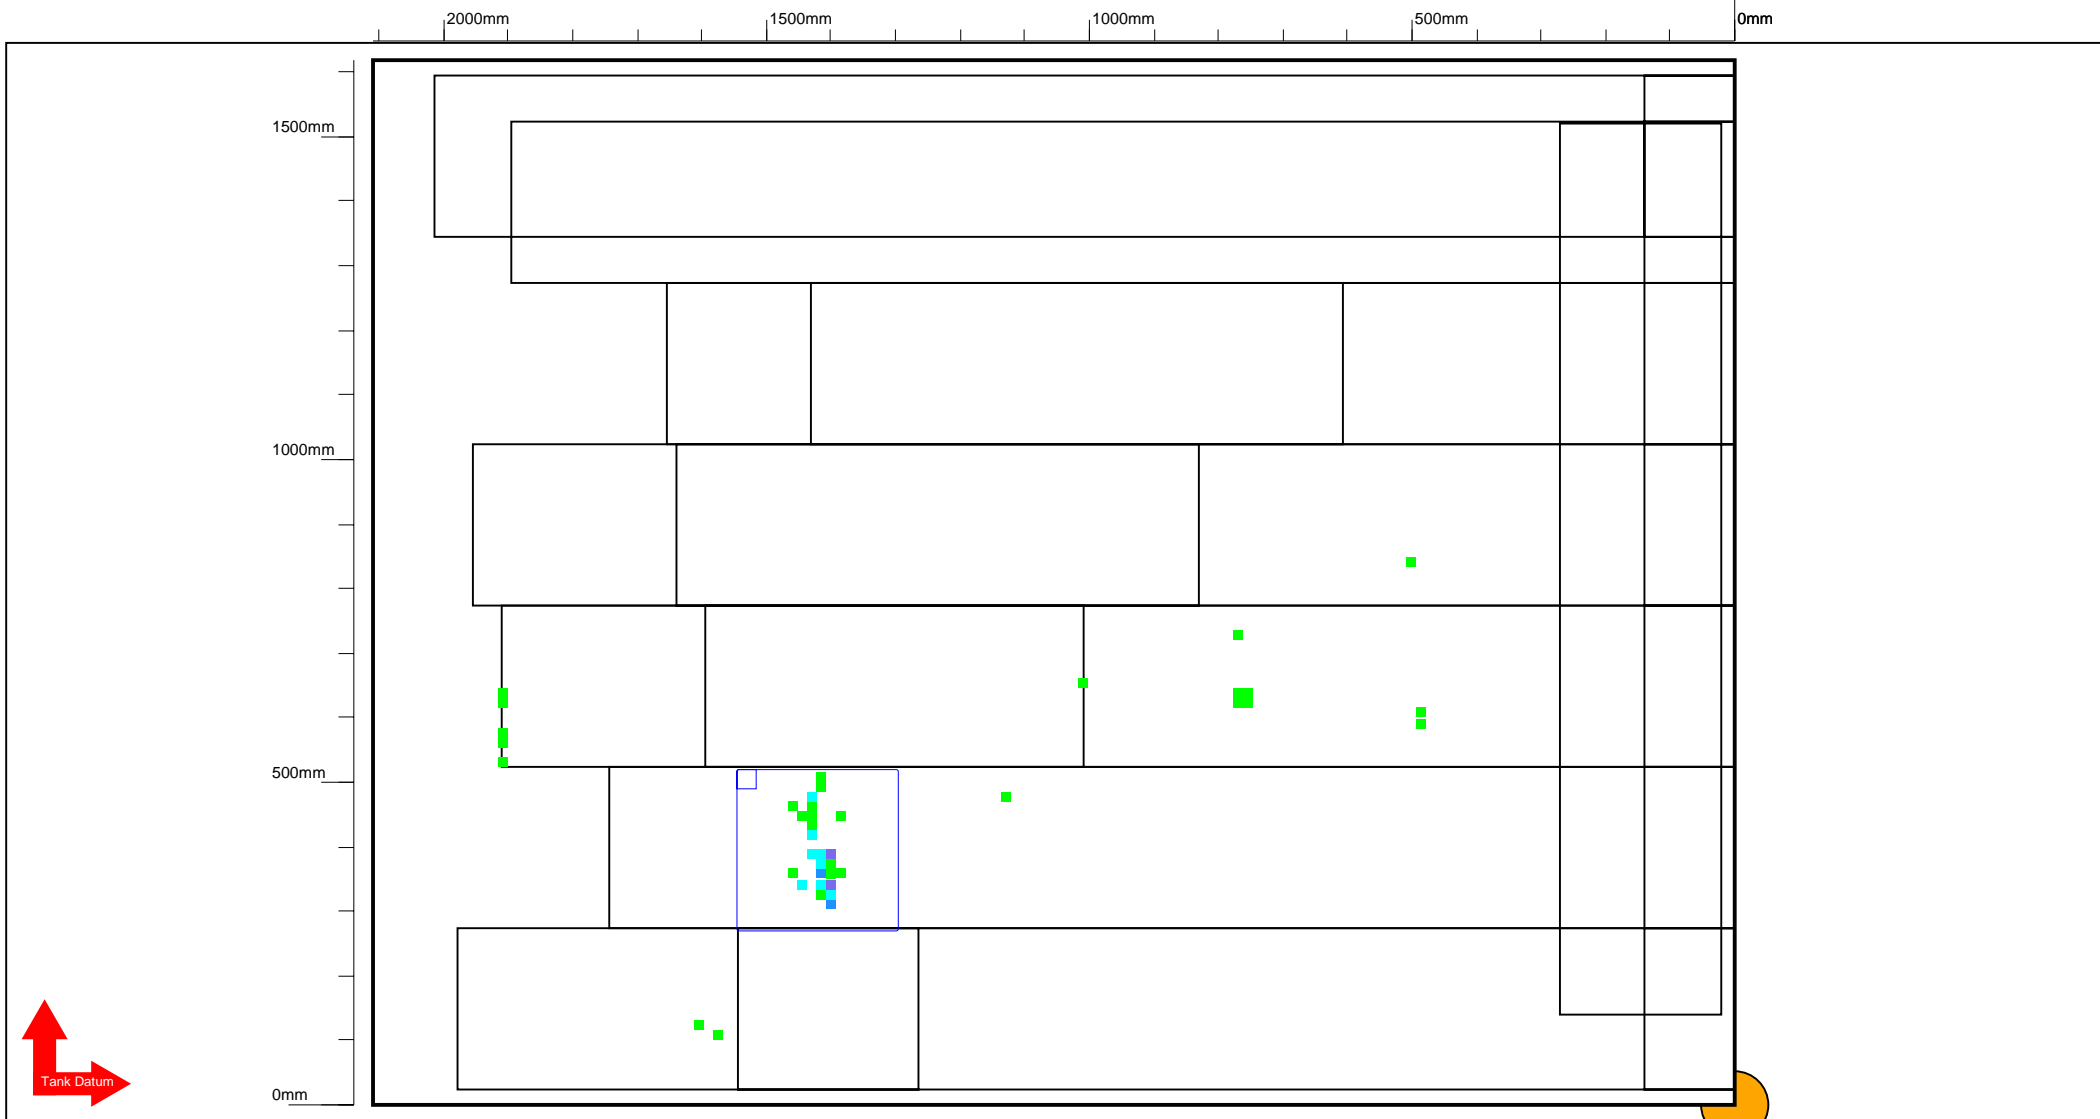
**Row:** 17  
**Plate Length:** 2110  
**Orientation:** Horizontal  
**Max discontinuity:** 73  
**Lower Threshold:** 40

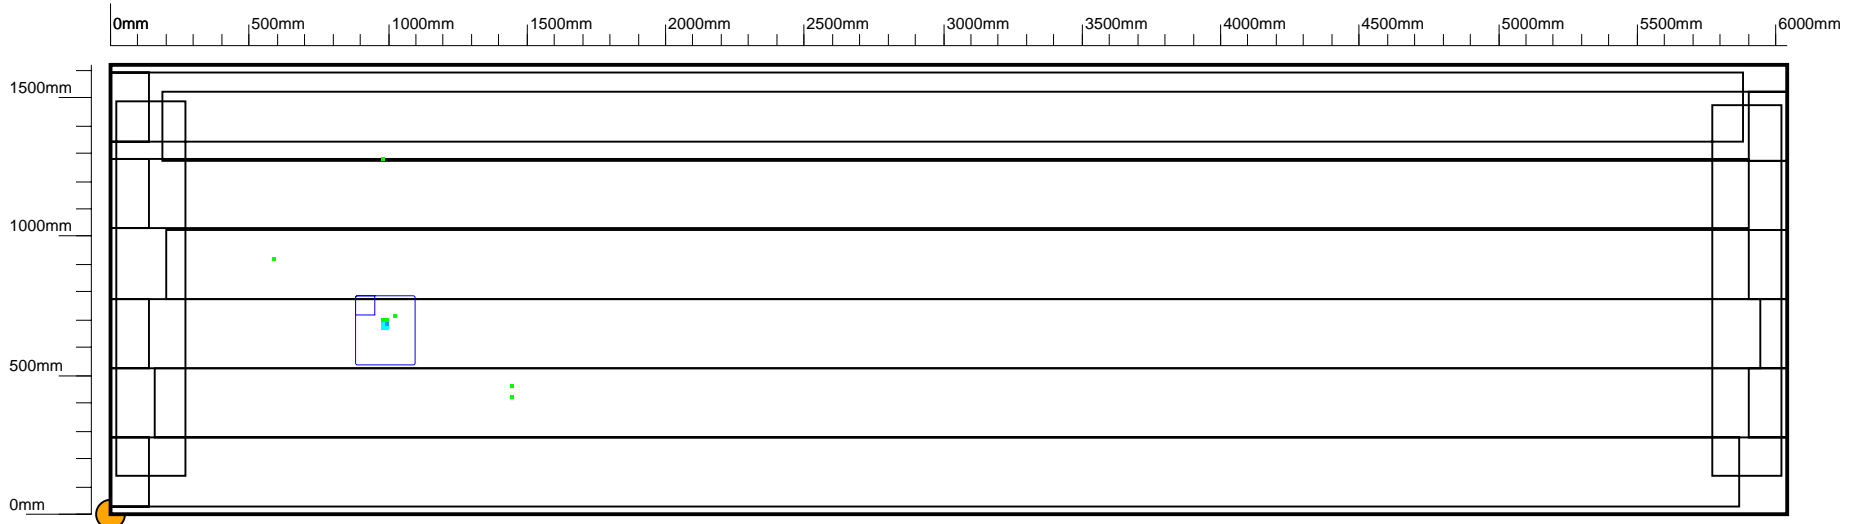
**Row:** 18  
**Plate Length:** 6040  
**Orientation:** Horizontal  
**Max discontinuity:** 61  
**Lower Threshold:** 40

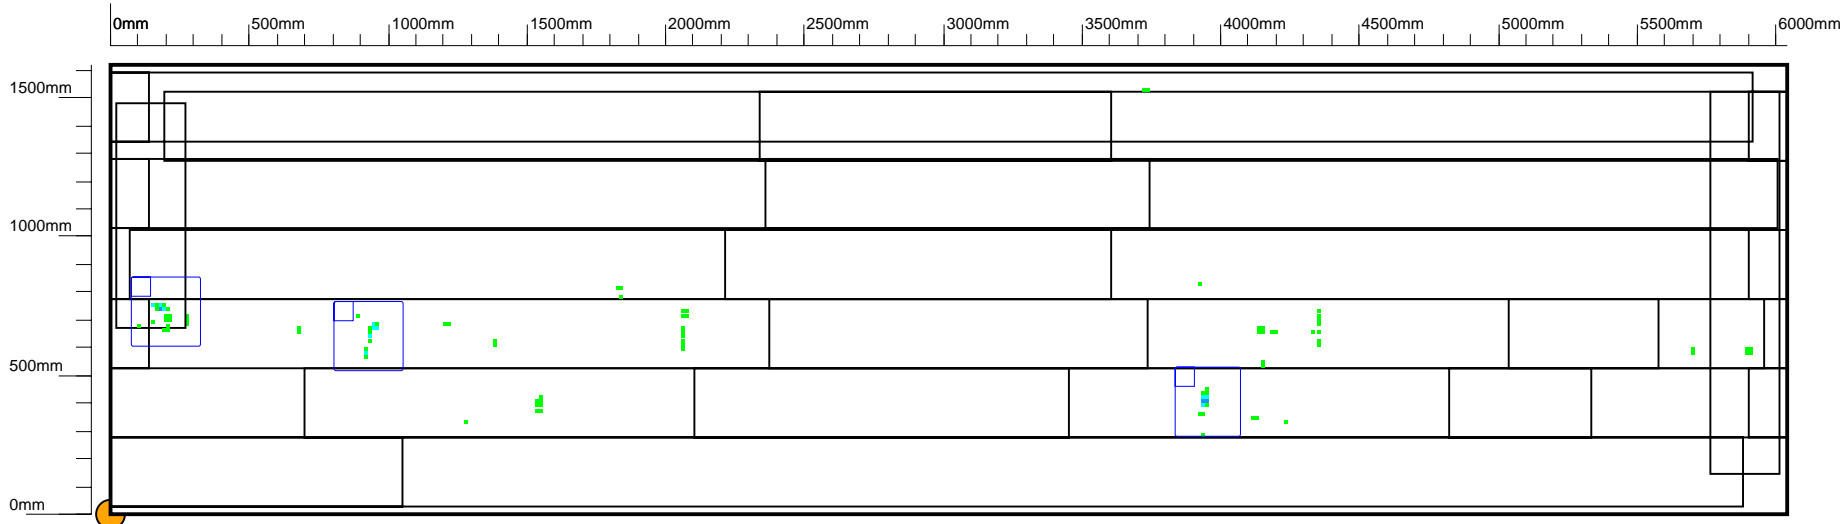
**Row:** 19  
**Plate Length:** 6040  
**Orientation:** Horizontal  
**Max discontinuity:** 63  
**Lower Threshold:** 40

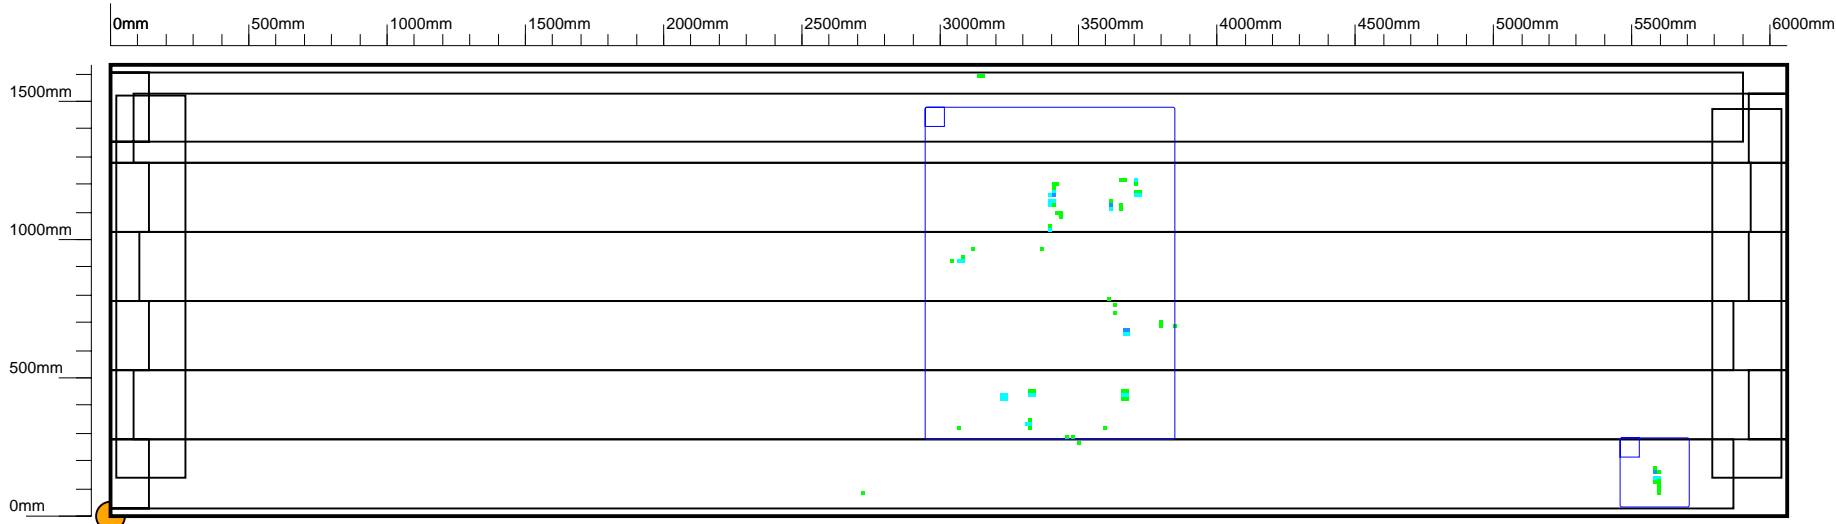
**Row:** 20  
**Plate Length:** 6060  
**Orientation:** Horizontal  
**Max discontinuity:** 65  
**Lower Threshold:** 40

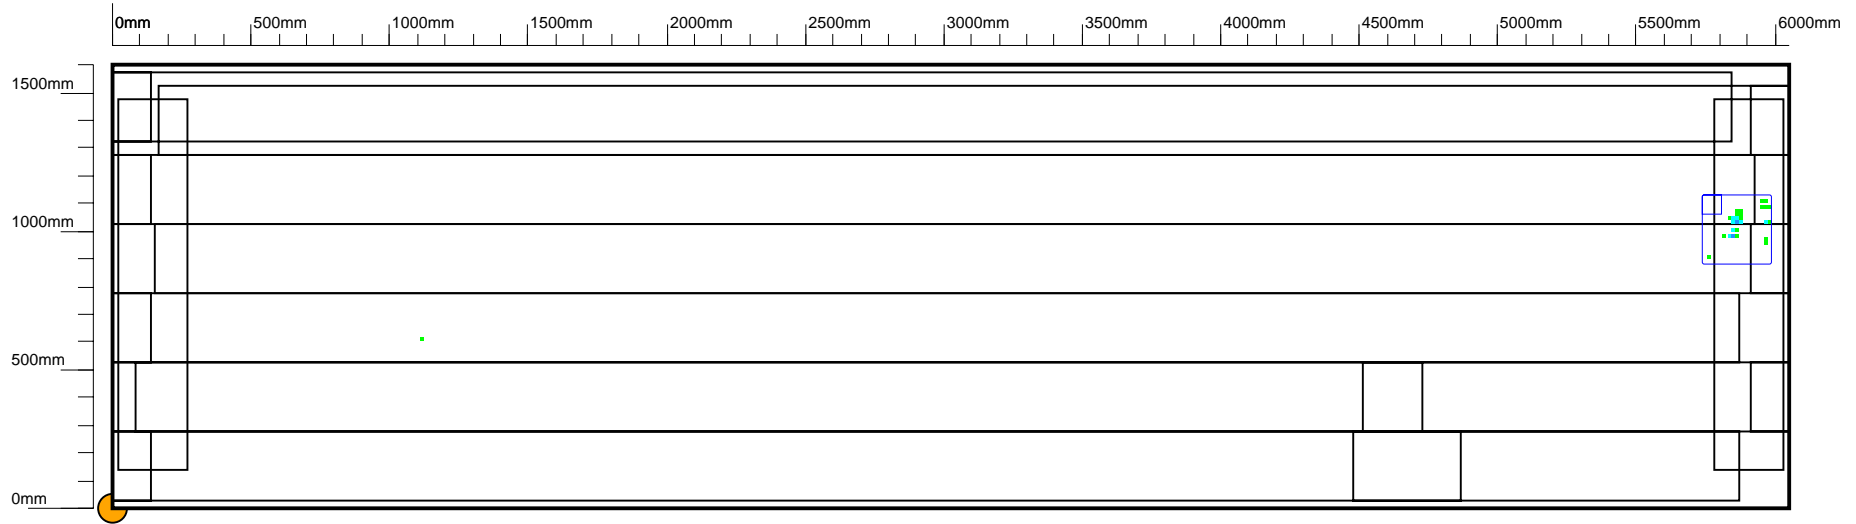
**Row:** 24  
**Plate Length:** 6050  
**Orientation:** Horizontal  
**Max discontinuity:** 61  
**Lower Threshold:** 40
