## Tank Inspection Report

Client	<b>Sample</b>
Location	<b>Sample</b>
Tank Identification	<b>Tank 8</b>
Inspection Date	<b>Sample</b>

## Results Summary – Tank 8

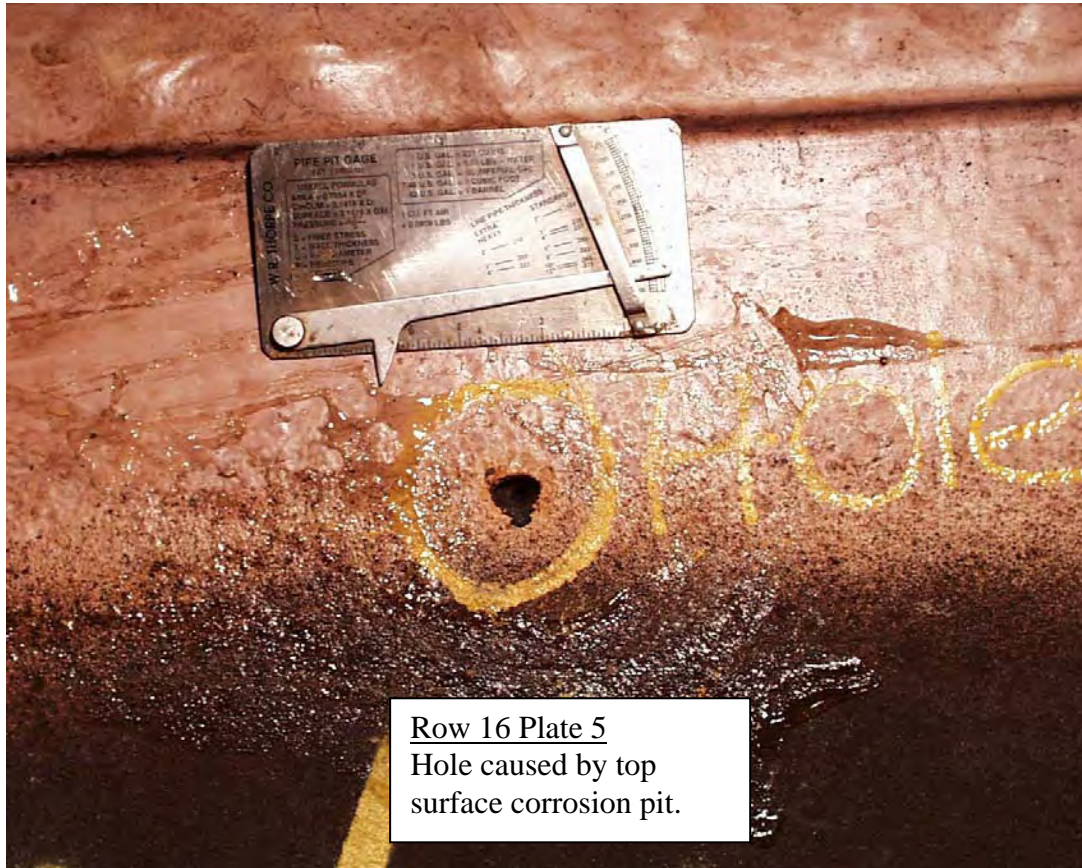
Row 16 Plate 5  
Hole caused by top surface corrosion pit.

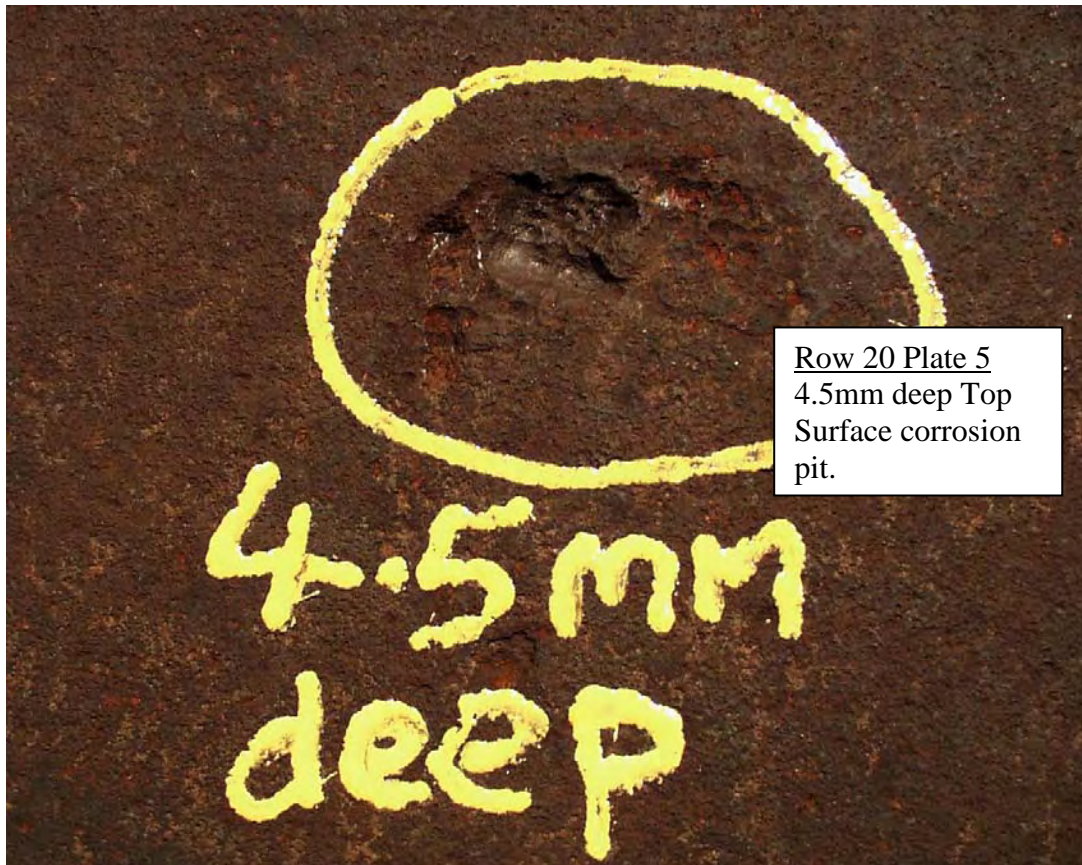
Row 20 Plate 5  
4.5mm deep Top Surface corrosion pit.

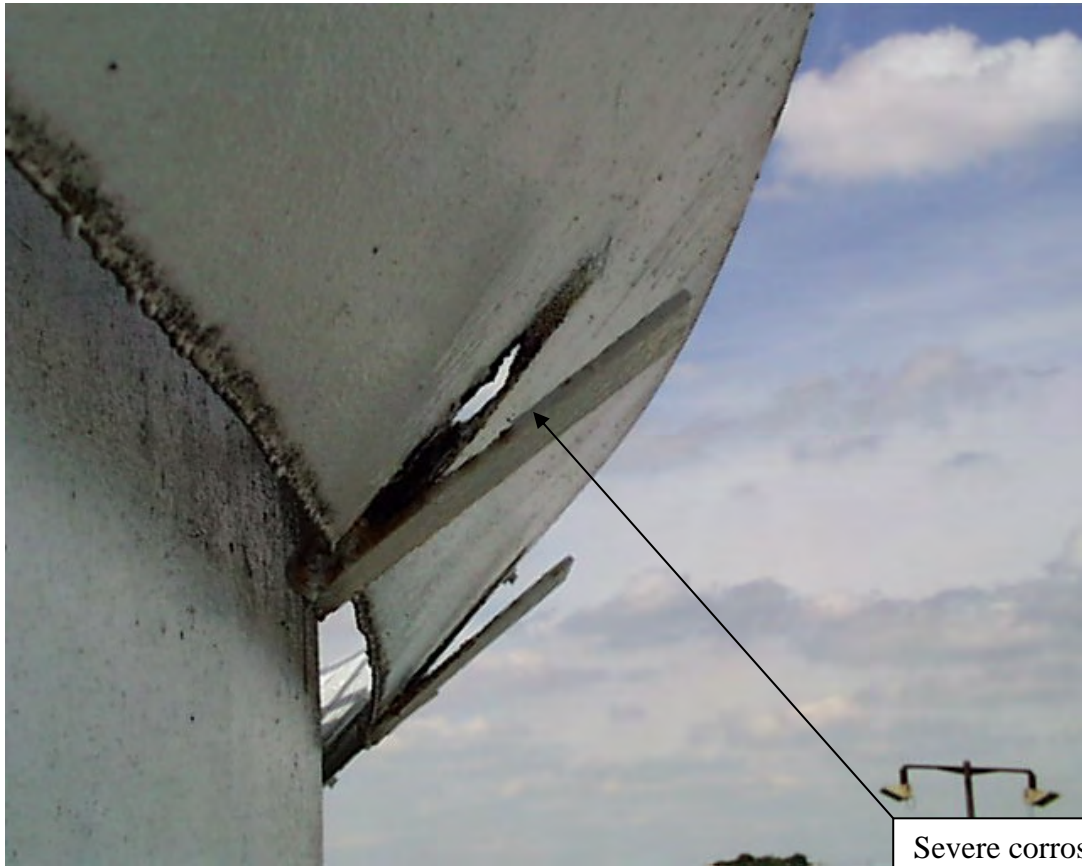
Severe corrosion  
around fixing brackets  
on Wind-guard

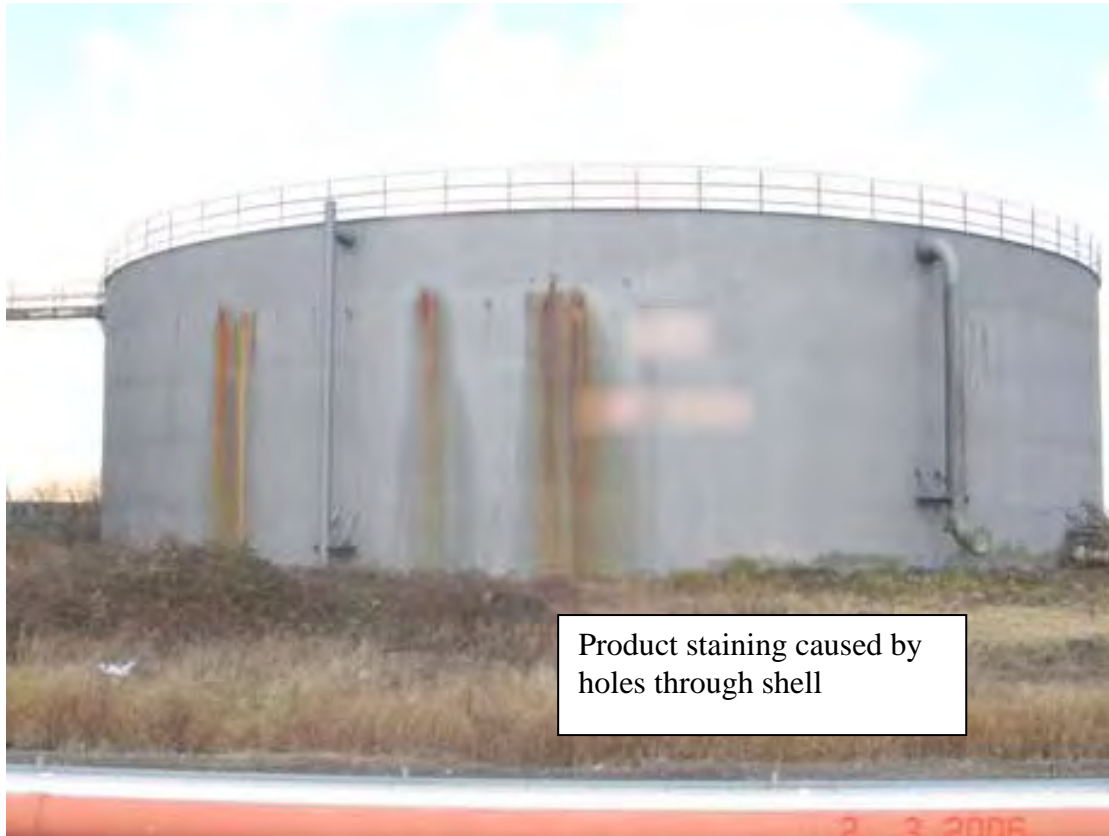
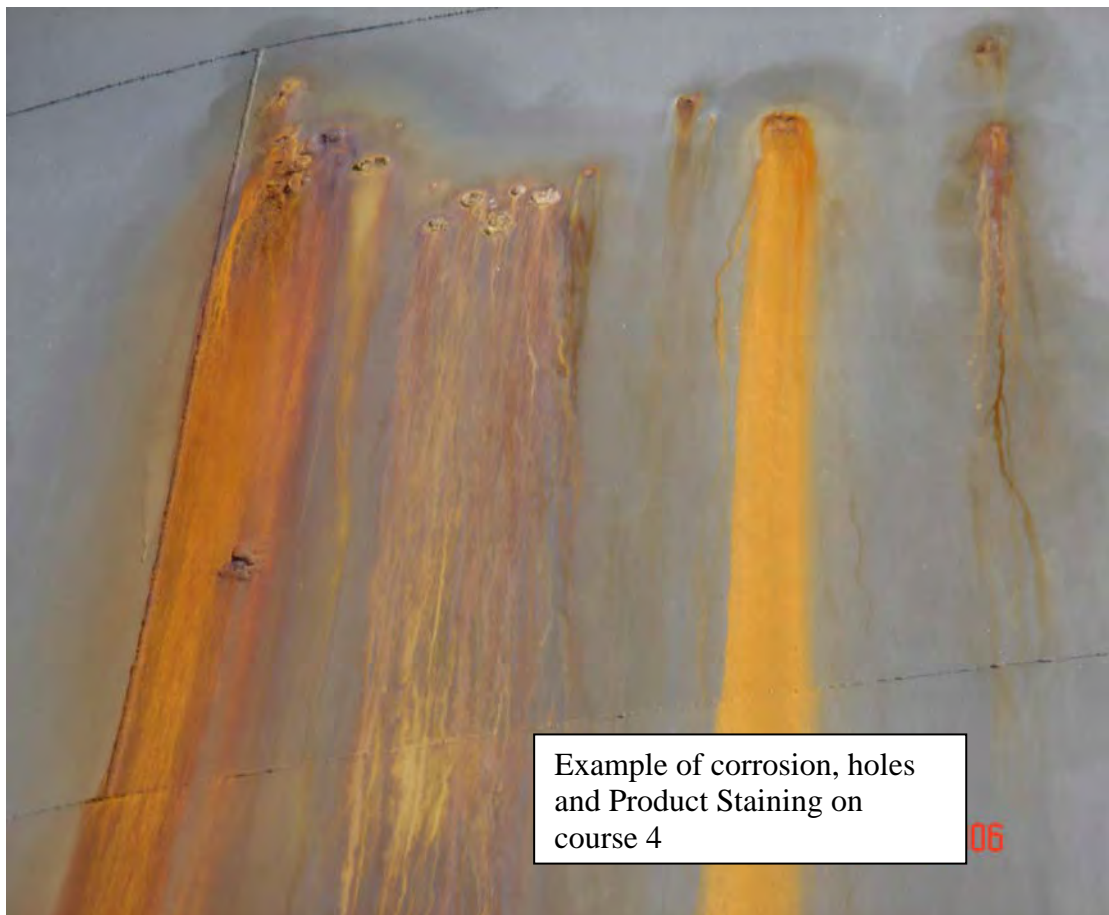
External Shell

Visual	Results	Corrosion, holes and staining from leaked product were noted at several areas on the external surfaces of the shell. With the exception of the above areas, the coating appeared to be in a generally good condition.
	Observations	It should be noted that the width of each B-Scan is approximately 5mm. Areas of severe corrosion resulting in holes were noted on Course 3, Course 4 and Course 5.
<b>External Floor plate (Toe)</b>	Cleanliness	The External floor plates were clean enough to allow a meaningful inspection to take place.
UT thickness measurements	Results	See attached data sheets.
Visual	Results	Several areas of bubbled or missing paint were noted which has led to Some corrosion lamination at edge of plates. The seal between the pad and the external floor plates has started to break down.
<b>Tank Roof Plates</b>	Cleanliness	The roof was clean enough to allow a meaningful inspection to take place.

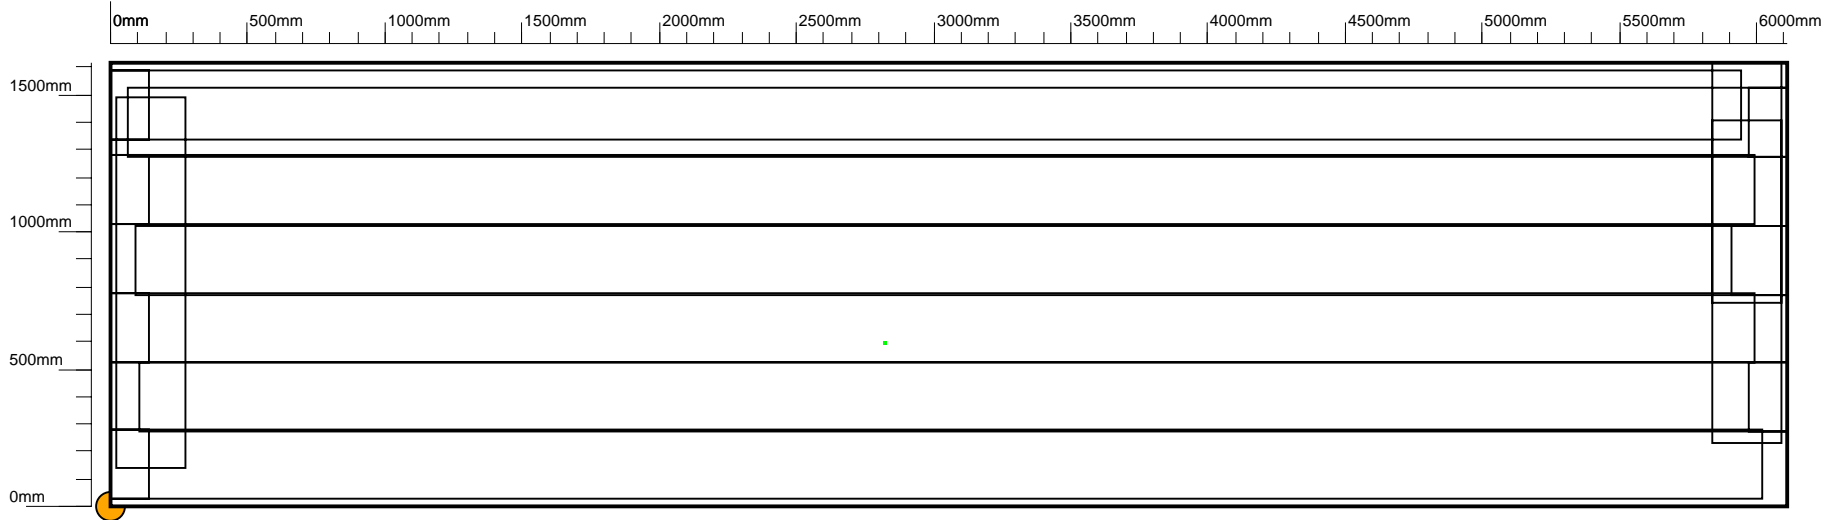
**Row:** 17  
**Plate Length:** 6110  
**Orientation:** Horizontal  
**Max discontinuity:** 41  
**Lower Threshold:** 40

**Plate:** 6  
**Plate Width:** 1620  
**Scan Method:** Raster  
**Discontinuity Count:** 1  
**Upper Threshold:** 100

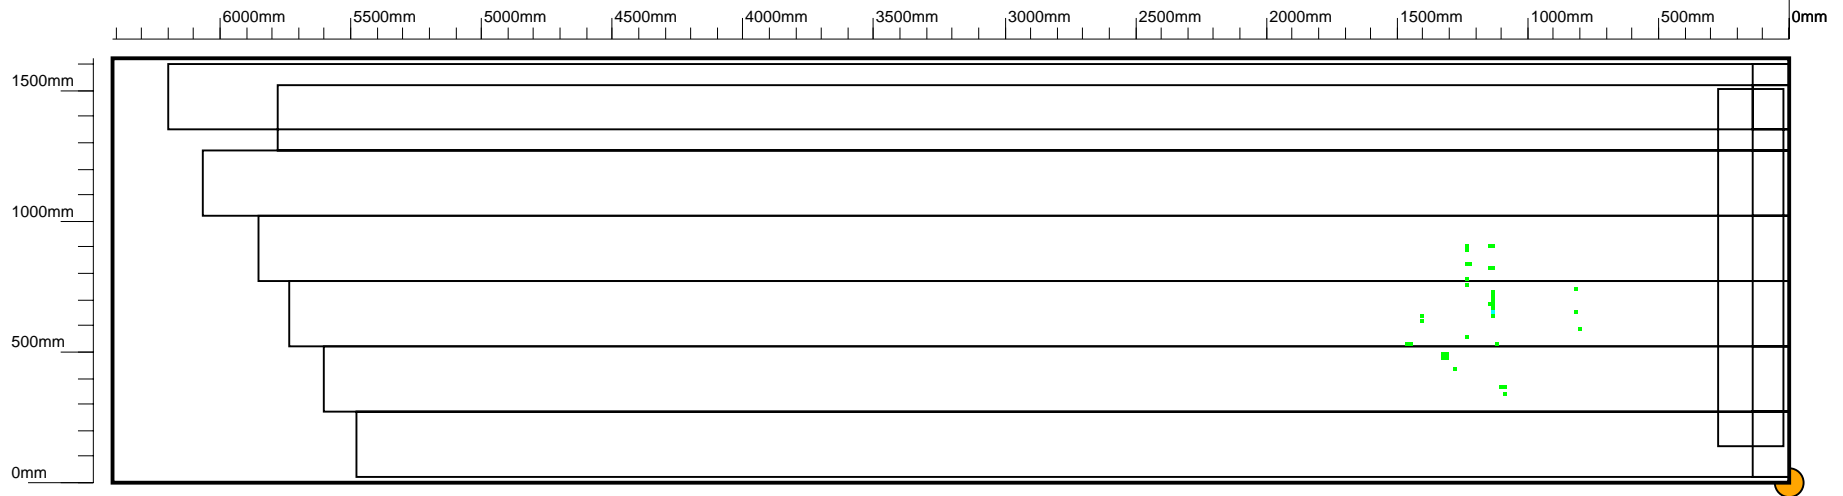
**Row:** 18  
**Plate Length:** 6410  
**Orientation:** Horizontal  
**Max discontinuity:** 52  
**Lower Threshold:** 40

**Plate:** 1  
**Plate Width:** 1620  
**Scan Method:** Uni-Directional  
**Discontinuity Count:** 35  
**Upper Threshold:** 100      **Import Threshold:** 20%

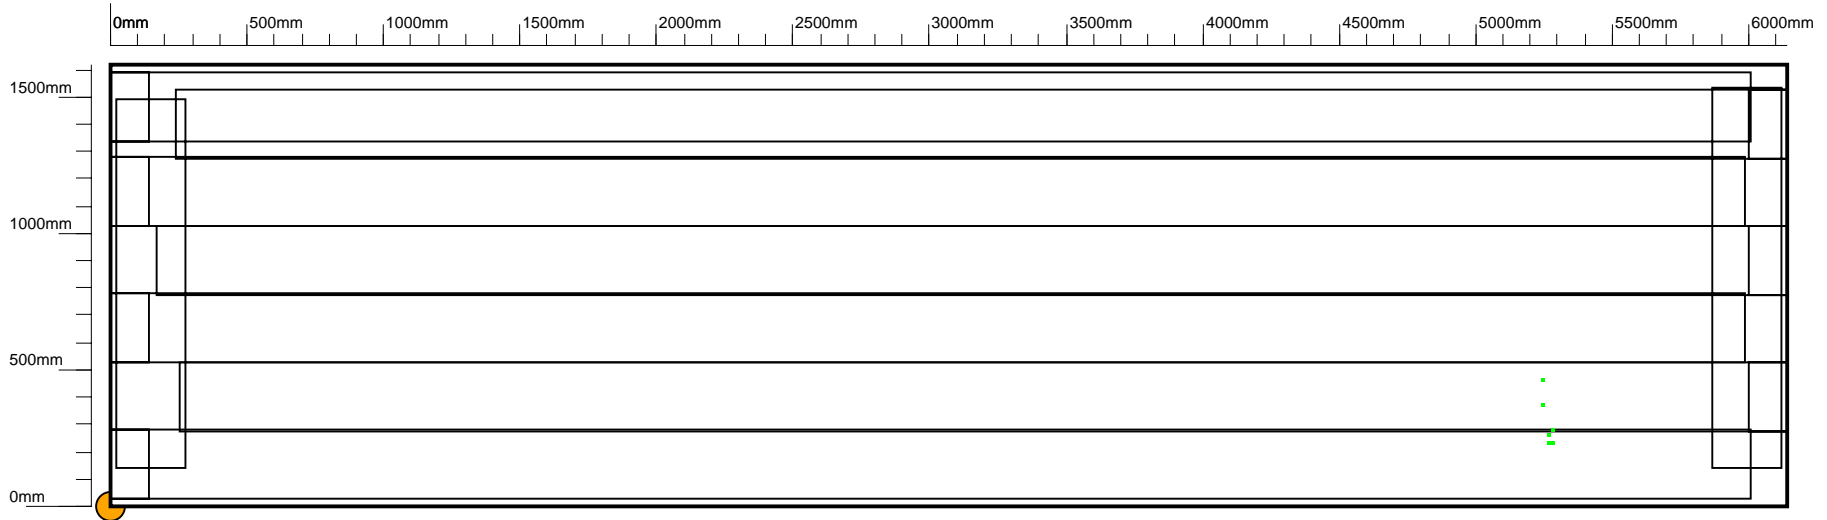
**Row:** 18  
**Plate Length:** 6140  
**Orientation:** Horizontal  
**Max discontinuity:** 46  
**Lower Threshold:** 40

**Plate:** 3  
**Plate Width:** 1620  
**Scan Method:** Raster  
**Discontinuity Count:** 6  
**Upper Threshold:** 100

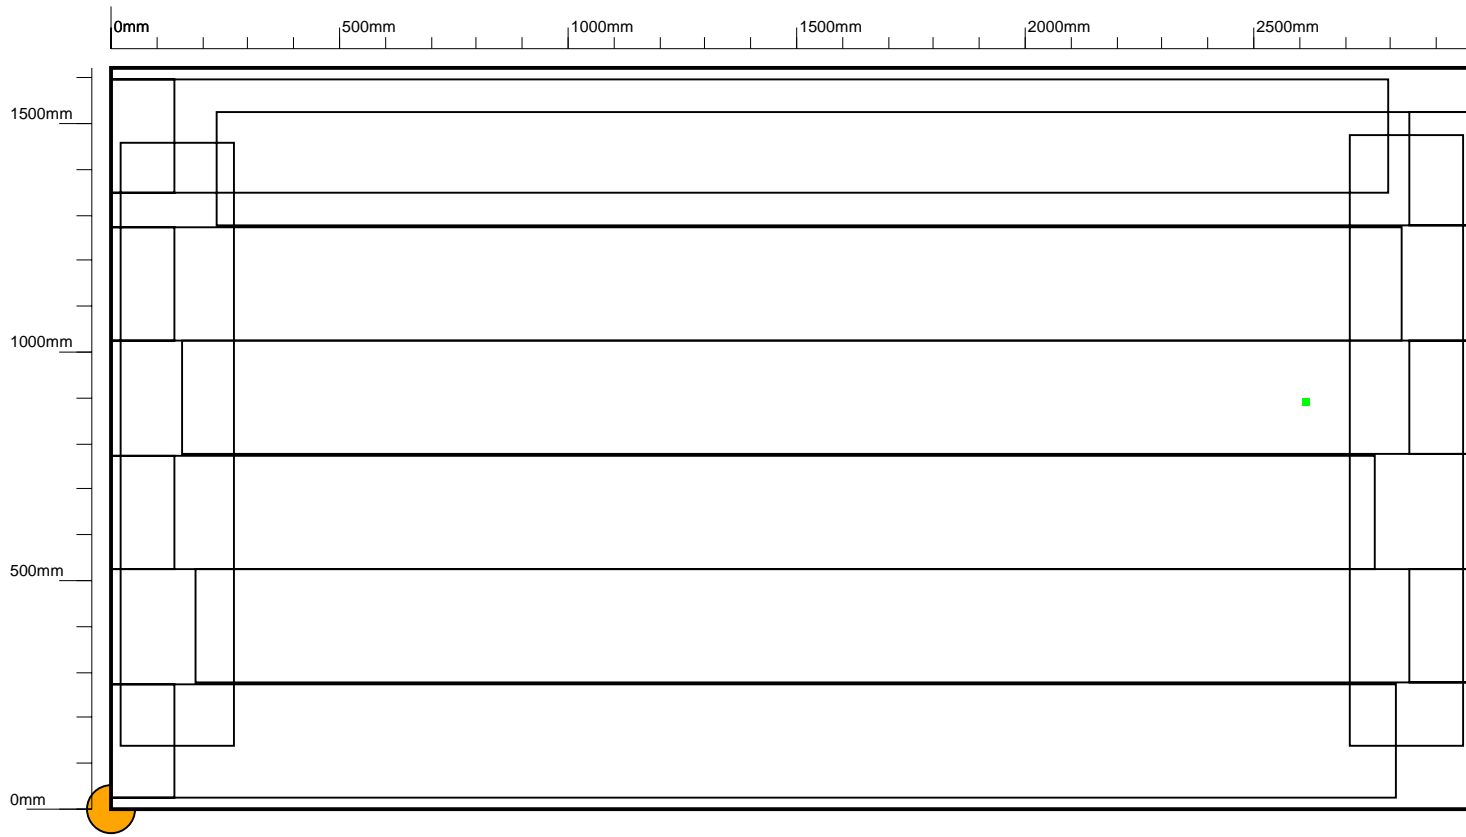
**Row:** 18  
**Plate Length:** 2980  
**Orientation:** Horizontal  
**Max discontinuity:** 40  
**Lower Threshold:** 40

**Plate:** 4  
**Plate Width:** 1620  
**Scan Method:** Raster  
**Discontinuity Count:** 1  
**Upper Threshold:** 100

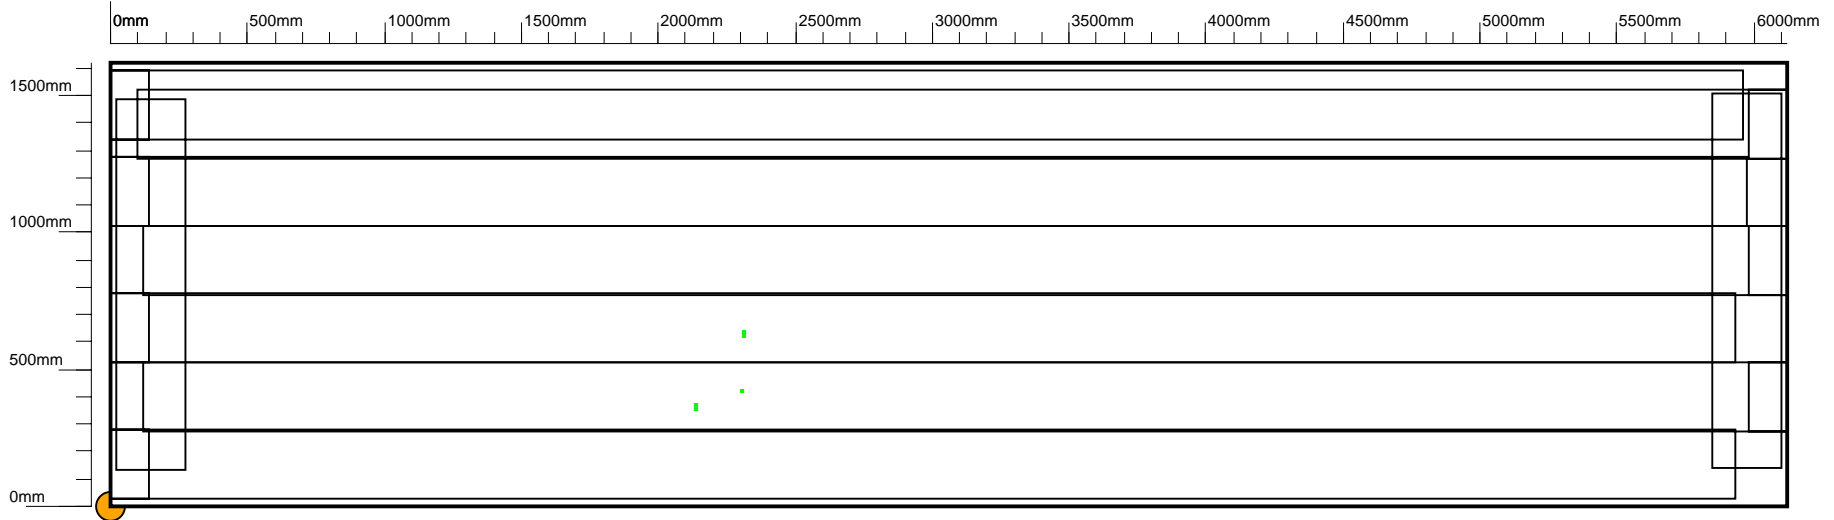
**Row:** 18  
**Plate Length:** 6120  
**Orientation:** Horizontal  
**Max discontinuity:** 44  
**Lower Threshold:** 40

**Plate:** 5  
**Plate Width:** 1620  
**Scan Method:** Raster  
**Discontinuity Count:** 5  
**Upper Threshold:** 100

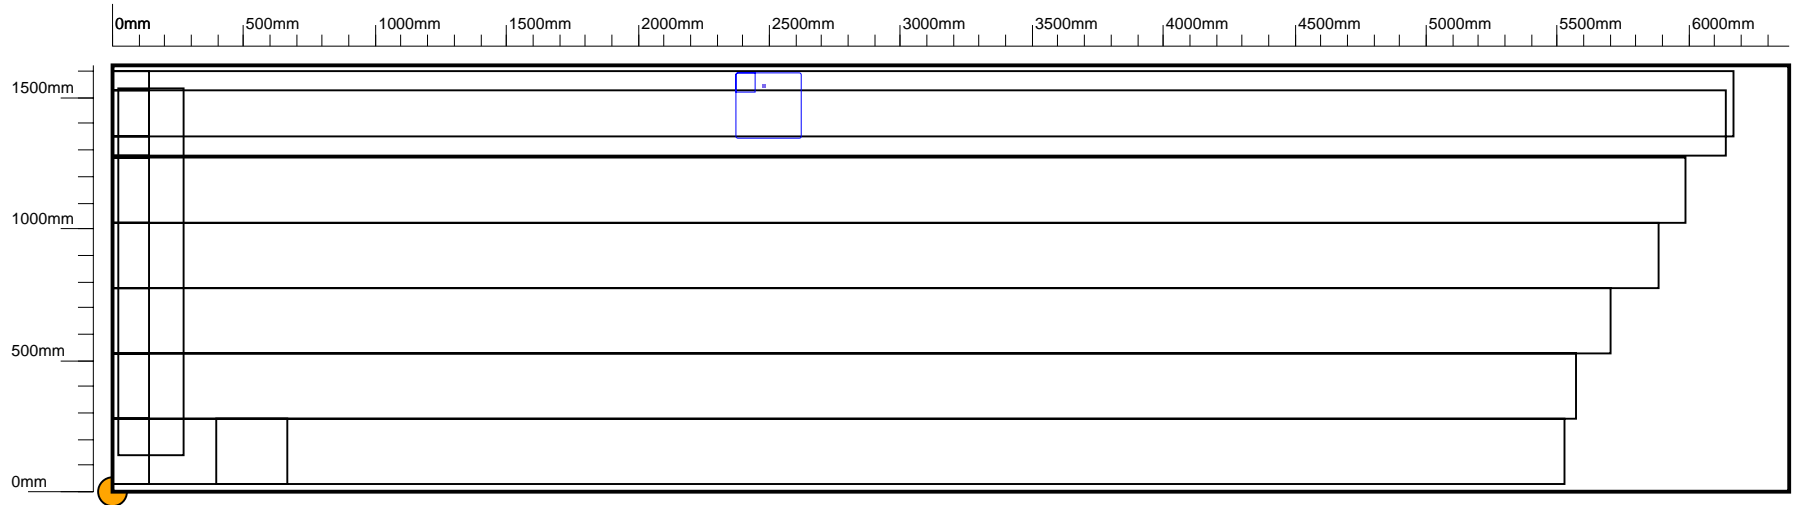
**Row:** 18  
**Plate Length:** 6380  
**Orientation:** Horizontal  
**Max discontinuity:** 75  
**Lower Threshold:** 40

**Plate:** 7  
**Plate Width:** 1620  
**Scan Method:** Uni-Directional  
**Discontinuity Count:** 1  
**Upper Threshold:** 100      **Import Threshold:** 20%

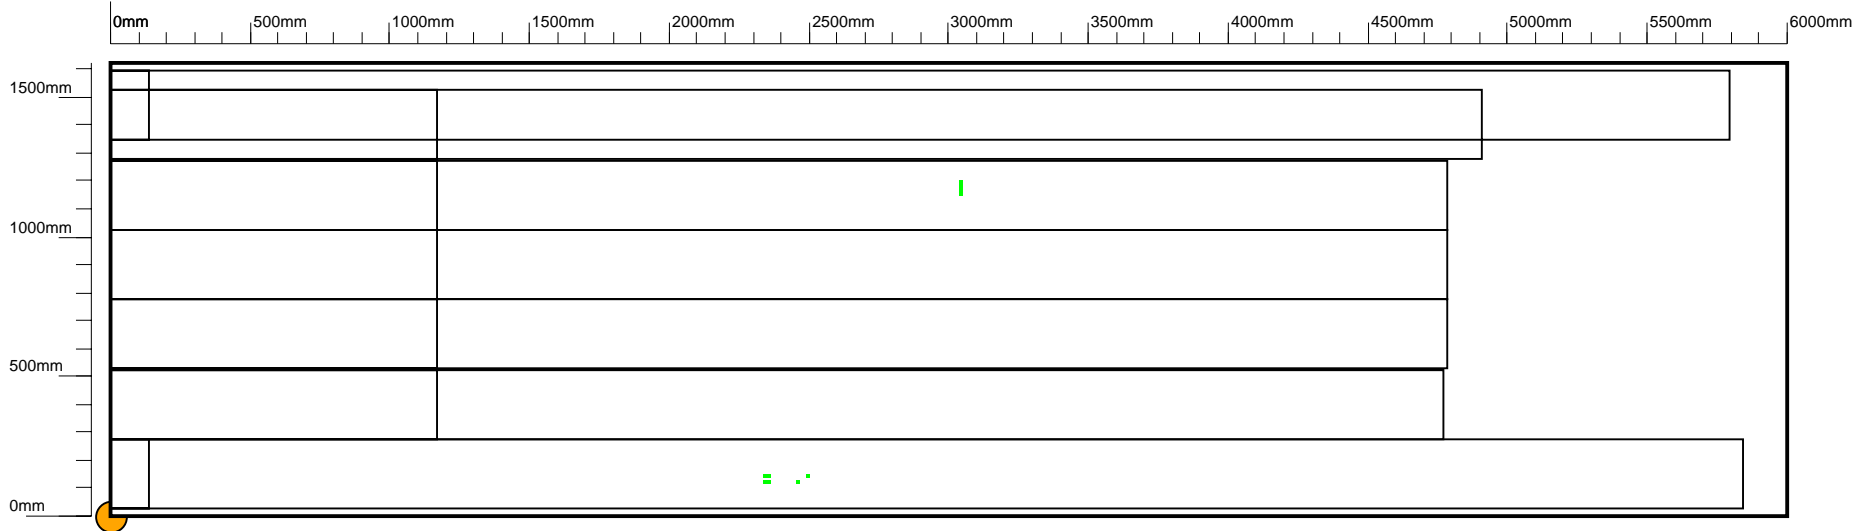
**Row:** 19  
**Plate Length:** 6000  
**Orientation:** Horizontal  
**Max discontinuity:** 45  
**Lower Threshold:** 40

**Plate:** 2  
**Plate Width:** 1620  
**Scan Method:** Uni-Directional  
**Discontinuity Count:** 10  
**Upper Threshold:** 100      **Import Threshold:** 20%

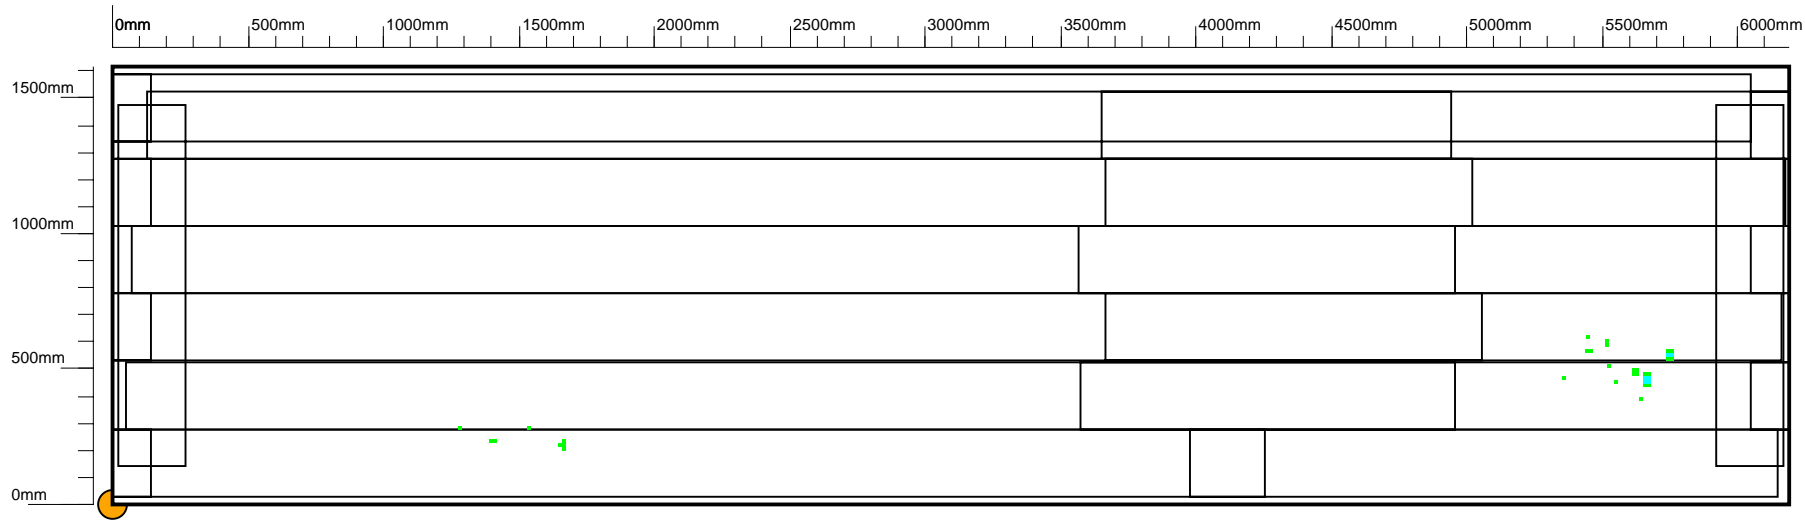
**Row:** 19  
**Plate Length:** 6190  
**Orientation:** Horizontal  
**Max discontinuity:** 59  
**Lower Threshold:** 40

**Plate:** 3  
**Plate Width:** 1620  
**Scan Method:** Raster  
**Discontinuity Count:** 35  
**Upper Threshold:** 100

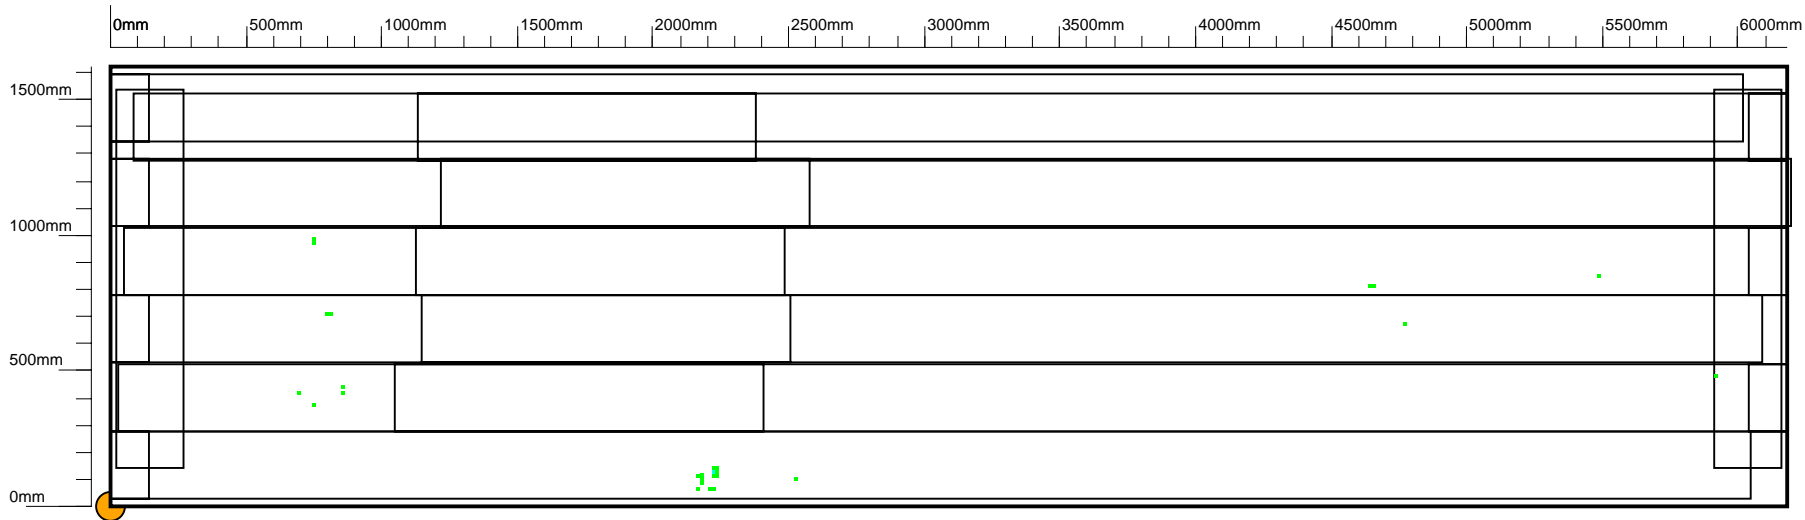
**Row:** 19  
**Plate Length:** 6180  
**Orientation:** Horizontal  
**Max discontinuity:** 50  
**Lower Threshold:** 40

**Plate:** 5  
**Plate Width:** 1620  
**Scan Method:** Raster  
**Discontinuity Count:** 27  
**Upper Threshold:** 100

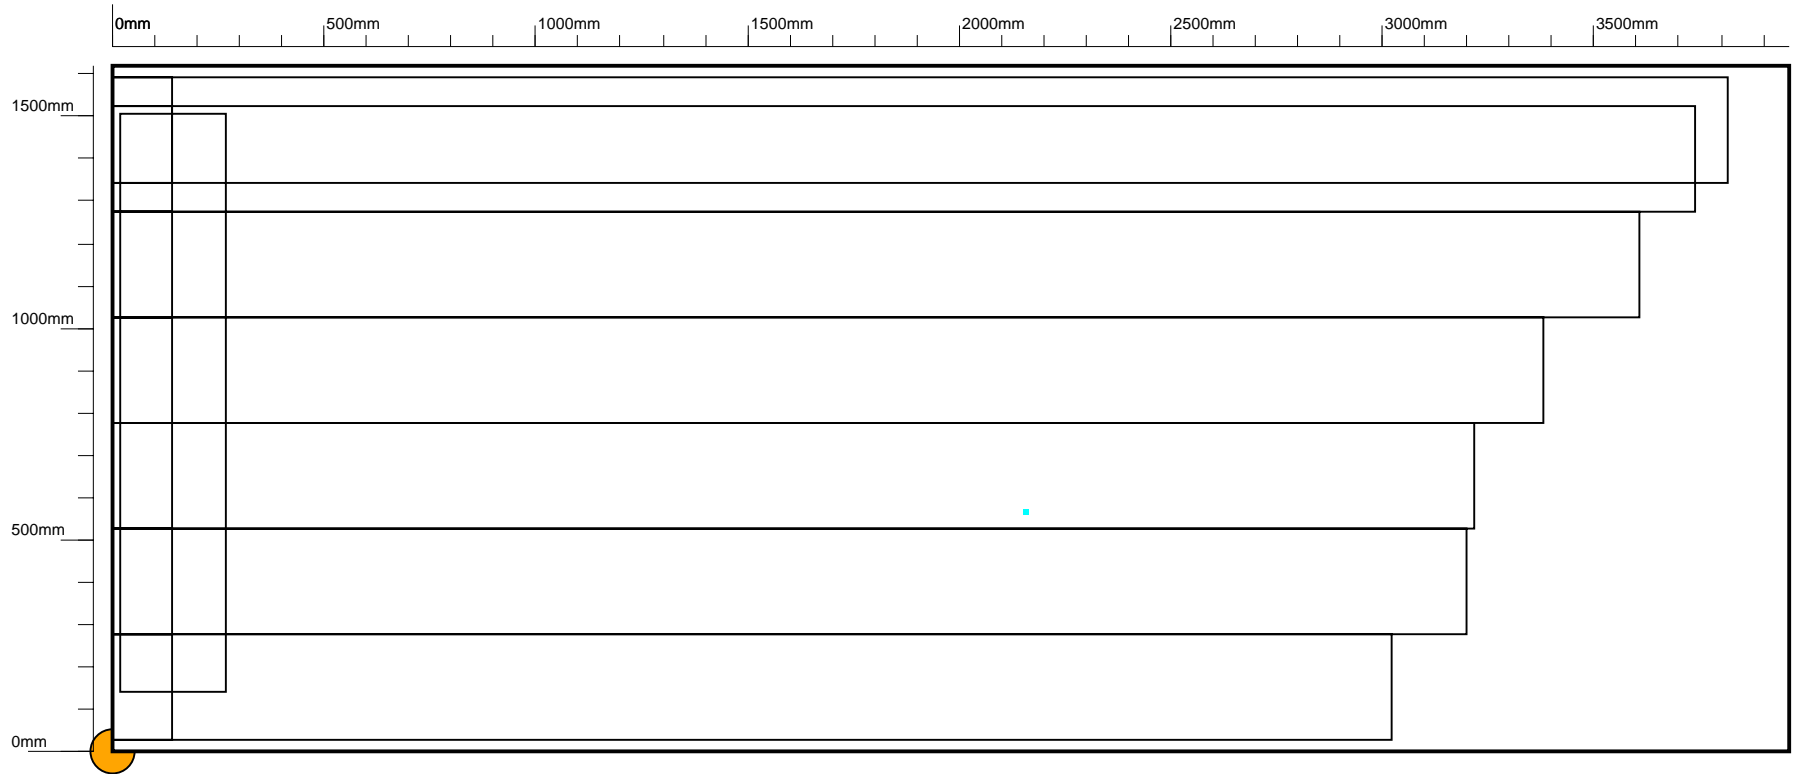
**Row:** 19  
**Plate Length:** 3960  
**Orientation:** Horizontal  
**Max discontinuity:** 50  
**Lower Threshold:** 40

**Plate:** 7  
**Plate Width:** 1620  
**Scan Method:** Uni-Directional  
**Discontinuity Count:** 1  
**Upper Threshold:** 100      **Import Threshold:** 20%

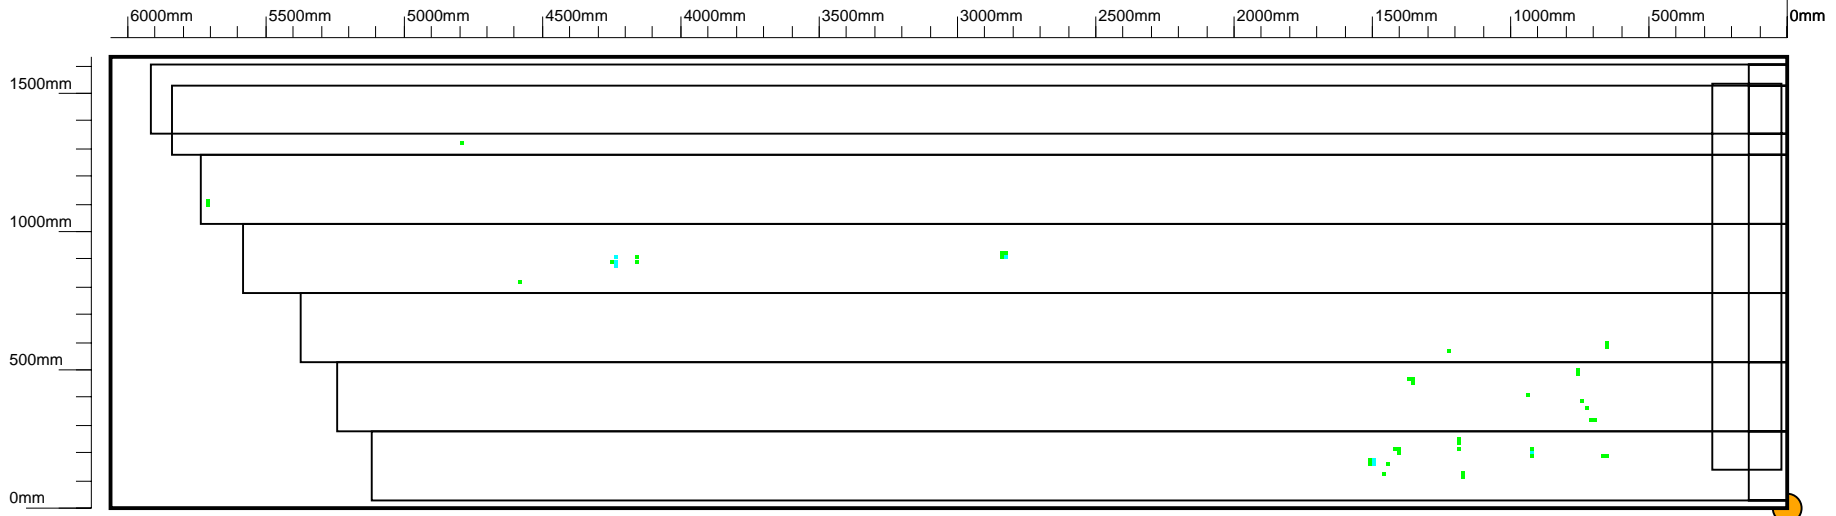
**Row:** 20  
**Plate Length:** 6060  
**Orientation:** Horizontal  
**Max discontinuity:** 58  
**Lower Threshold:** 40

**Plate:** 1  
**Plate Width:** 1630  
**Scan Method:** Uni-Directional  
**Discontinuity Count:** 46  
**Upper Threshold:** 100      **Import Threshold:** 20%

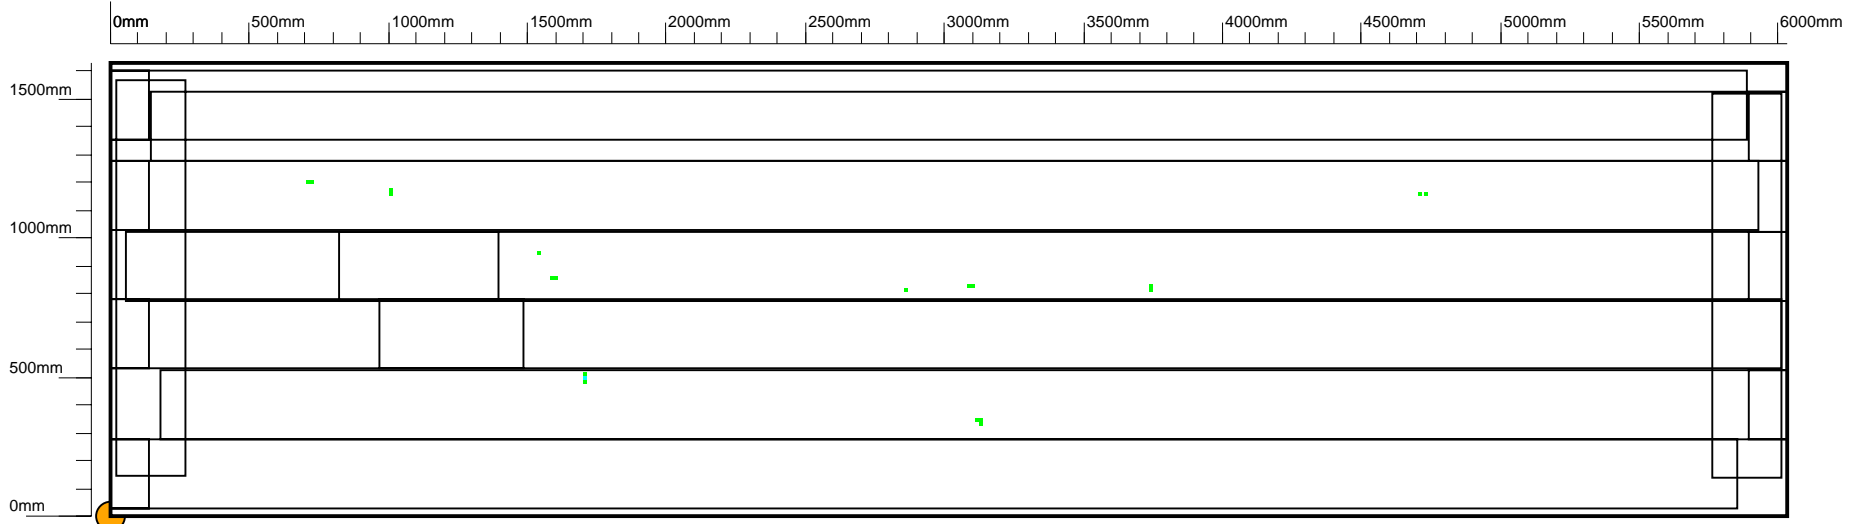
**Row:** 20  
**Plate Length:** 6030  
**Orientation:** Horizontal  
**Max discontinuity:** 51  
**Lower Threshold:** 40

**Plate:** 2  
**Plate Width:** 1630  
**Scan Method:** Raster  
**Discontinuity Count:** 20  
**Upper Threshold:** 100

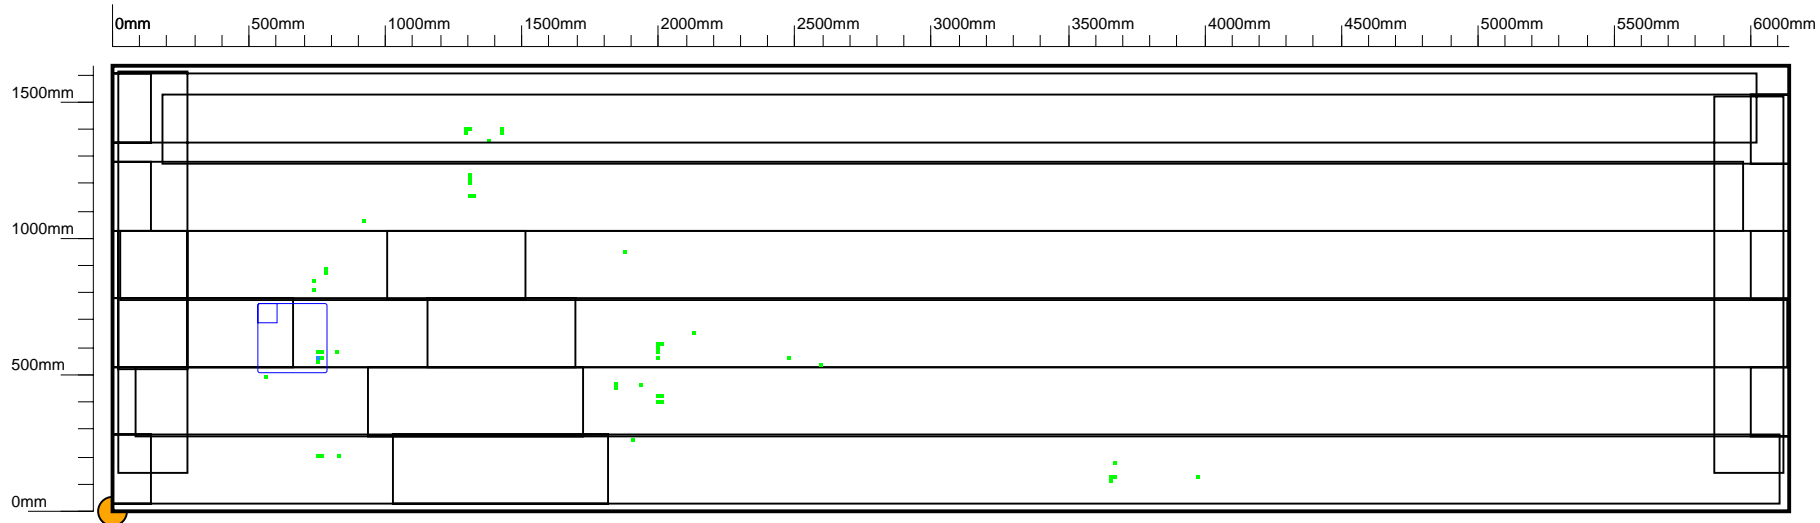
**Row:** 20  
**Plate Length:** 6140  
**Orientation:** Horizontal  
**Max discontinuity:** 60  
**Lower Threshold:** 40

**Plate:** 3  
**Plate Width:** 1630  
**Scan Method:** Raster  
**Discontinuity Count:** 48  
**Upper Threshold:** 100

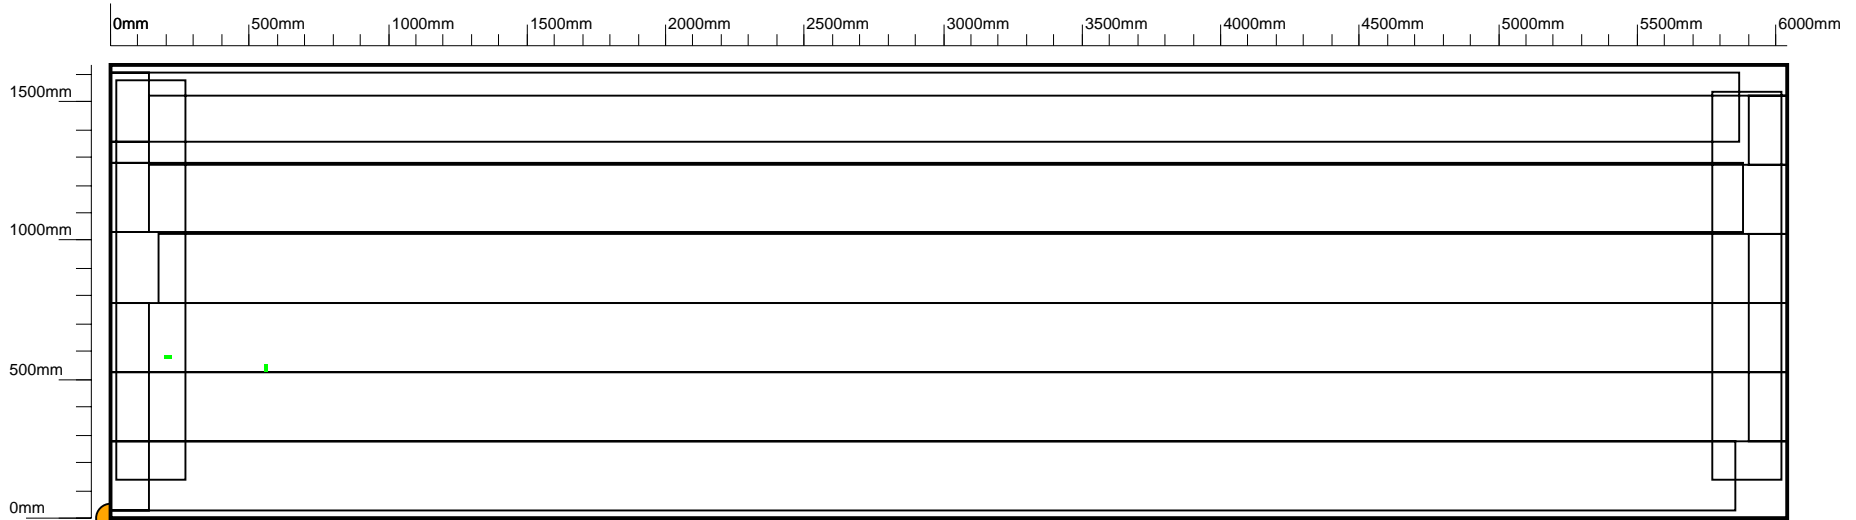
**Row:** 20  
**Plate Length:** 6040  
**Orientation:** Horizontal  
**Max discontinuity:** 48  
**Lower Threshold:** 40

**Plate:** 4  
**Plate Width:** 1630  
**Scan Method:** Raster  
**Discontinuity Count:** 4  
**Upper Threshold:** 100

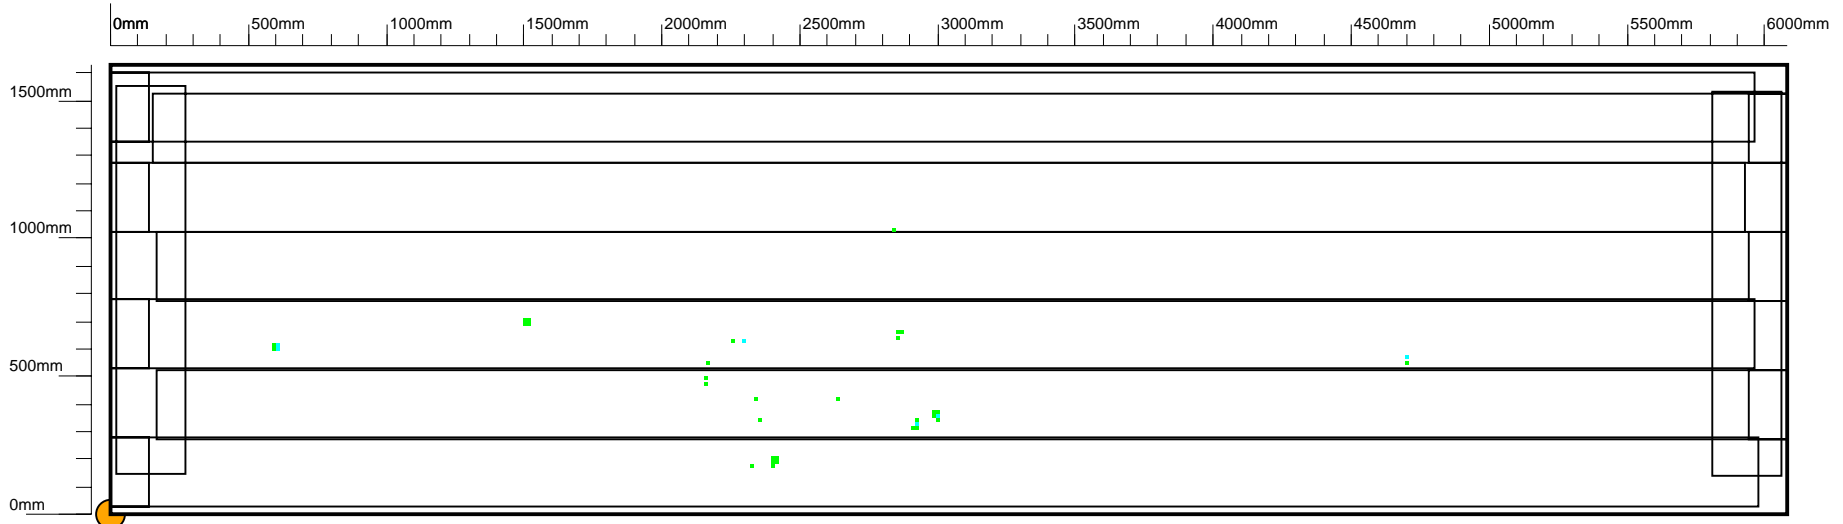
**Row:** 21  
**Plate Length:** 6080  
**Orientation:** Horizontal  
**Max discontinuity:** 56  
**Lower Threshold:** 40

**Plate:** 2  
**Plate Width:** 1630  
**Scan Method:** Raster  
**Discontinuity Count:** 37  
**Upper Threshold:** 100

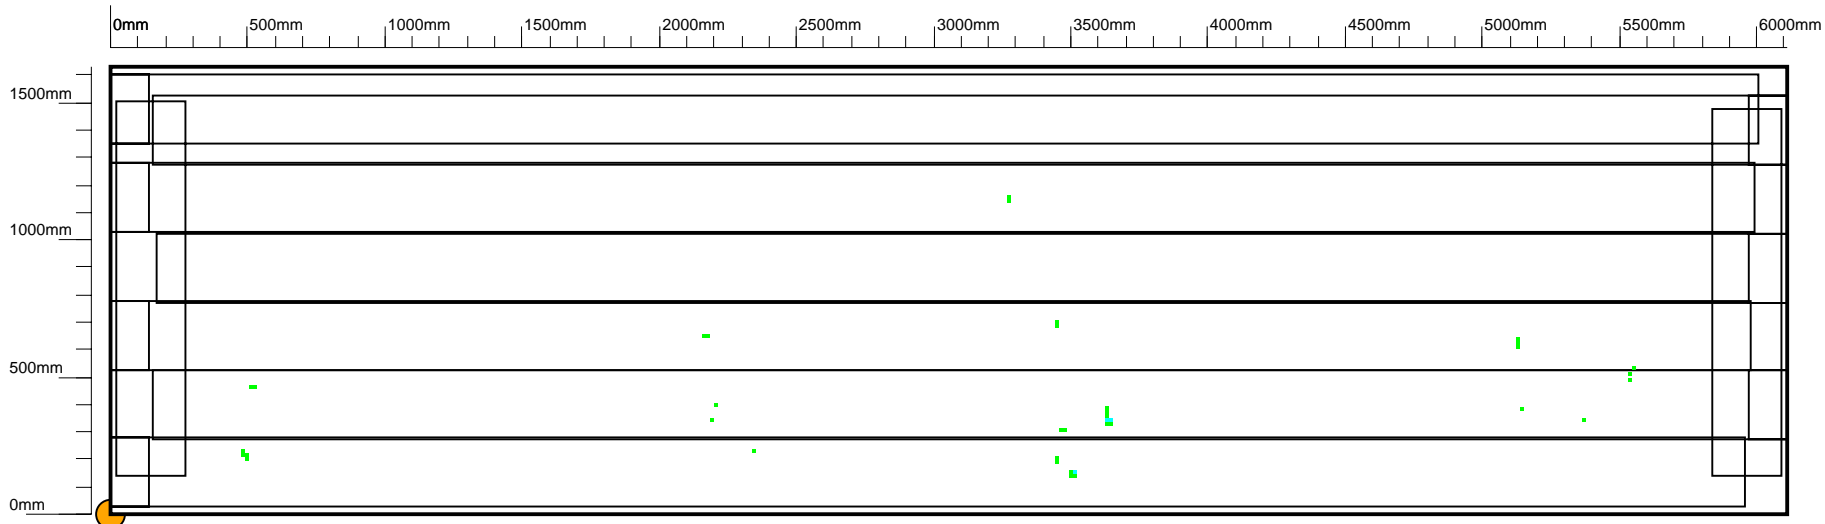
**Row:** 21  
**Plate Length:** 6110  
**Orientation:** Horizontal  
**Max discontinuity:** 51  
**Lower Threshold:** 40

**Plate:** 3  
**Plate Width:** 1630  
**Scan Method:** Raster  
**Discontinuity Count:** 38  
**Upper Threshold:** 100
