## Tank Inspection Report

Client	<b>Sample</b>
Location	<b>Sample</b>
Tank Identification	<b>Tank 8</b>
Inspection Date	<b>Sample</b>

## Results Summary – Tank 8

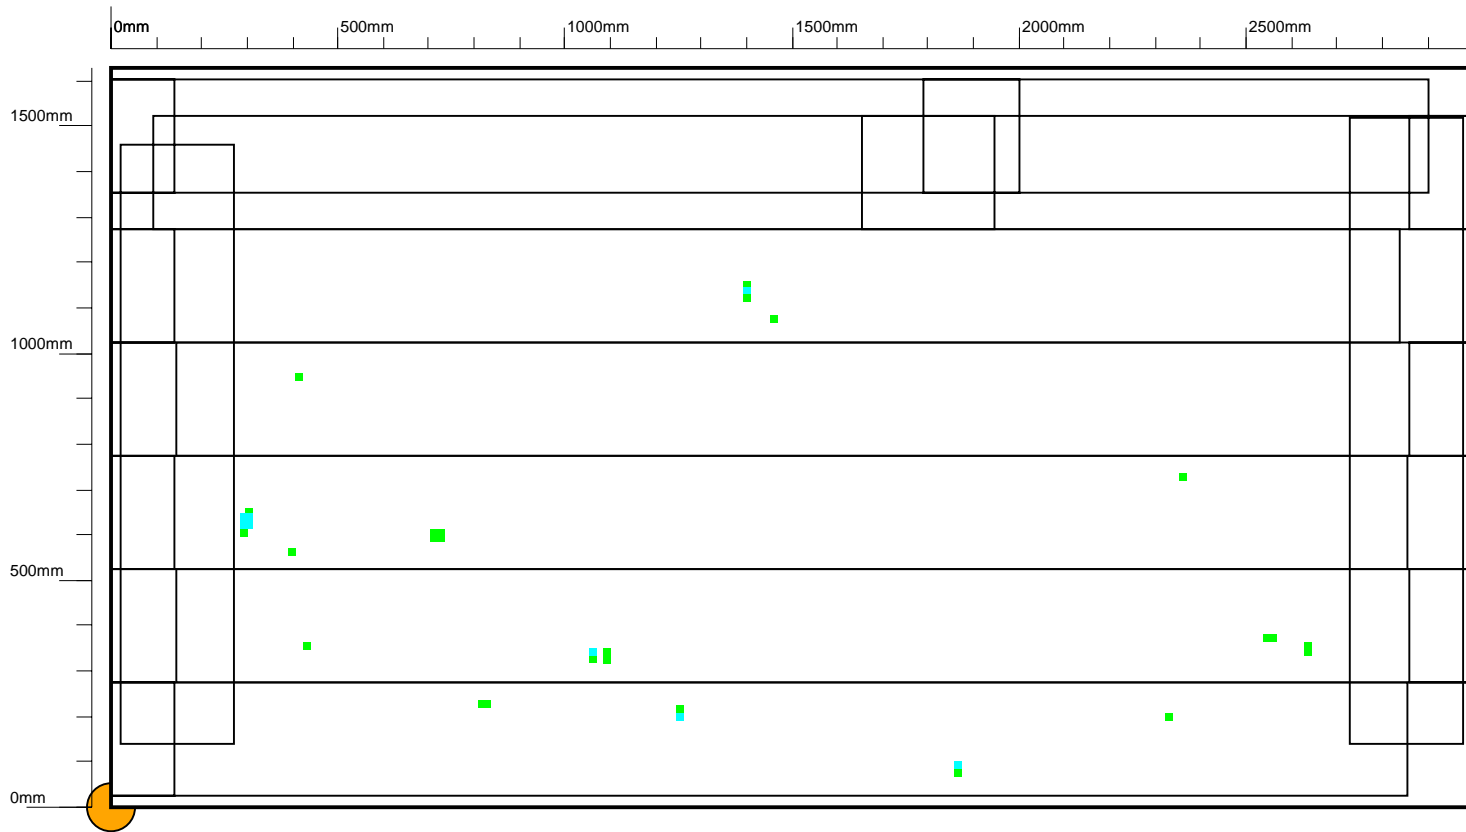
**Row:** 21  
**Plate Length:** 3000  
**Orientation:** Horizontal  
**Max discontinuity:** 59  
**Lower Threshold:** 40

**Plate:** 4  
**Plate Width:** 1630  
**Scan Method:** Raster  
**Discontinuity Count:** 33  
**Upper Threshold:** 100

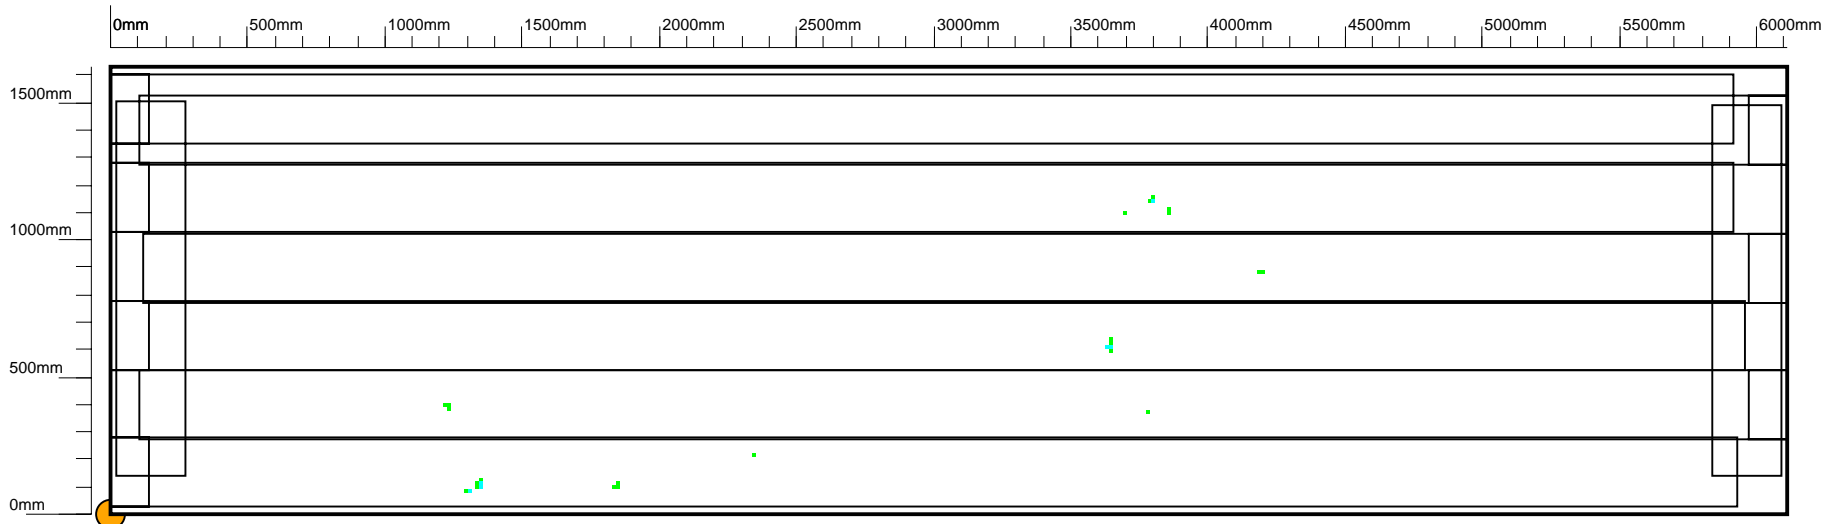
**Row:** 21  
**Plate Length:** 6110  
**Orientation:** Horizontal  
**Max discontinuity:** 56  
**Lower Threshold:** 40

**Plate:** 5  
**Plate Width:** 1630  
**Scan Method:** Raster  
**Discontinuity Count:** 28  
**Upper Threshold:** 100

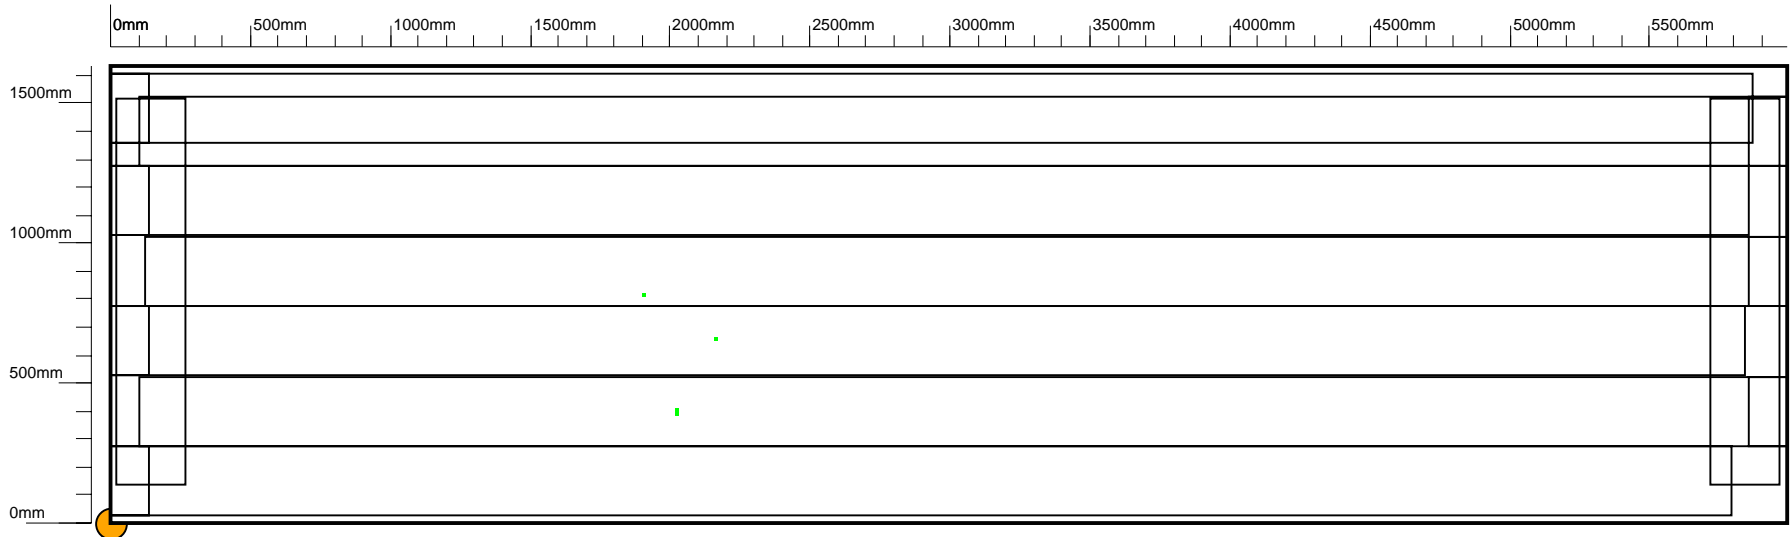
**Row:** 21  
**Plate Length:** 5990  
**Orientation:** Horizontal  
**Max discontinuity:** 47  
**Lower Threshold:** 40

**Plate:** 6  
**Plate Width:** 1630  
**Scan Method:** Raster  
**Discontinuity Count:** 4  
**Upper Threshold:** 100

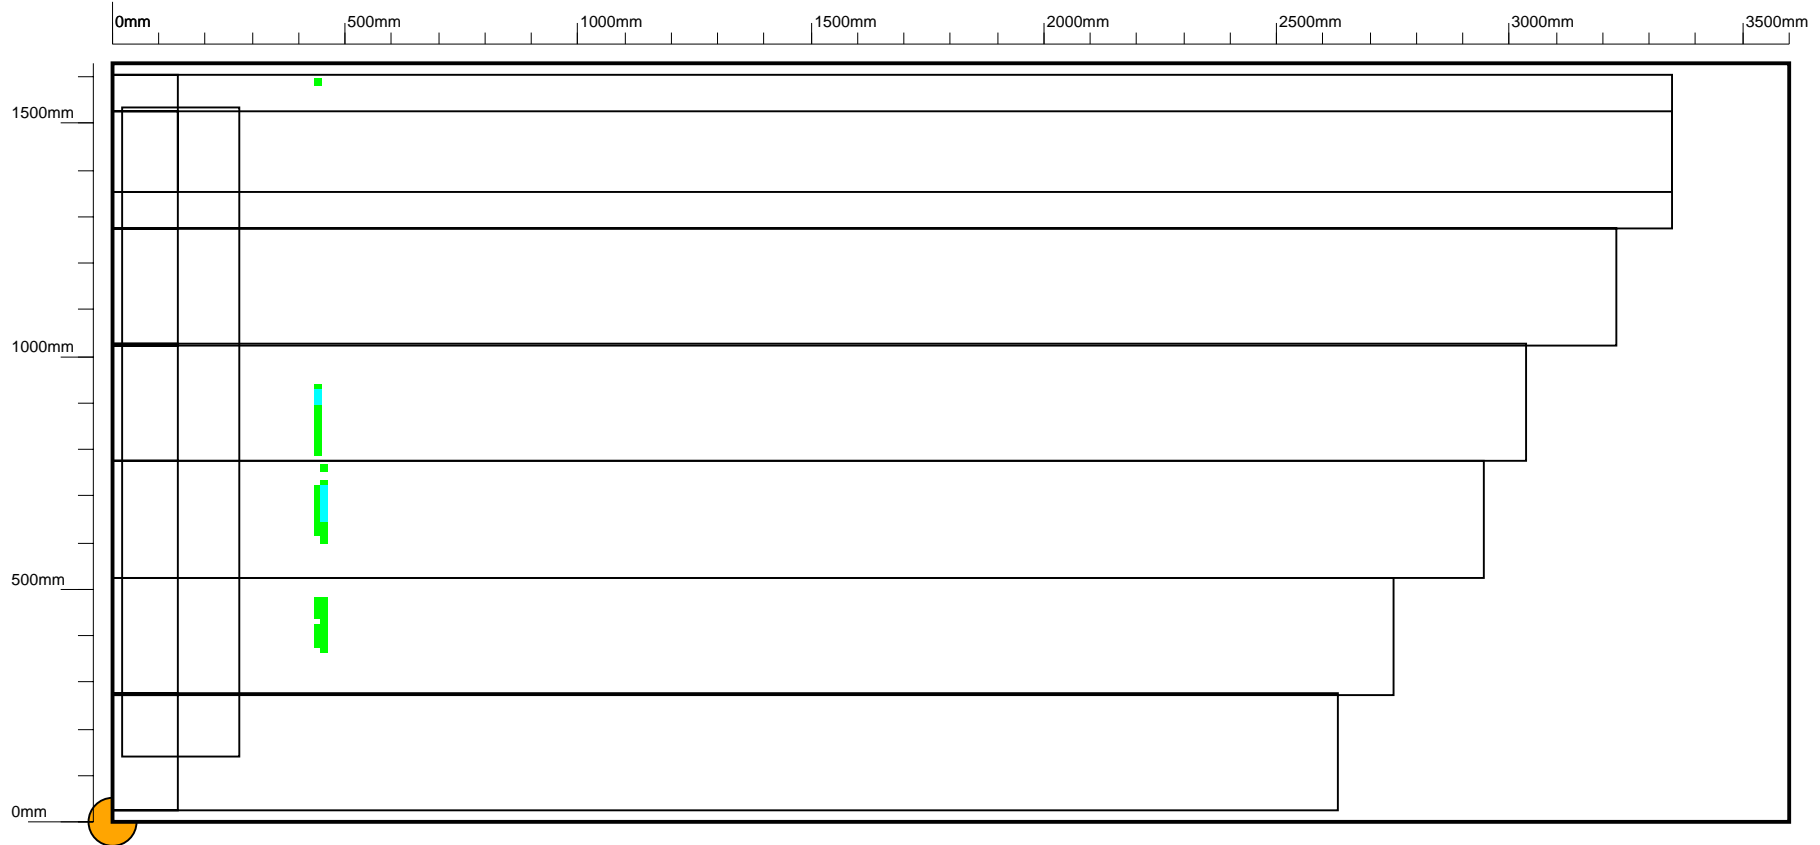
**Row:** 21  
**Plate Length:** 3600  
**Orientation:** Horizontal  
**Max discontinuity:** 55  
**Lower Threshold:** 40

**Plate:** 7  
**Plate Width:** 1630  
**Scan Method:** Uni-Directional  
**Discontinuity Count:** 42  
**Upper Threshold:** 100      **Import Threshold:** 20%

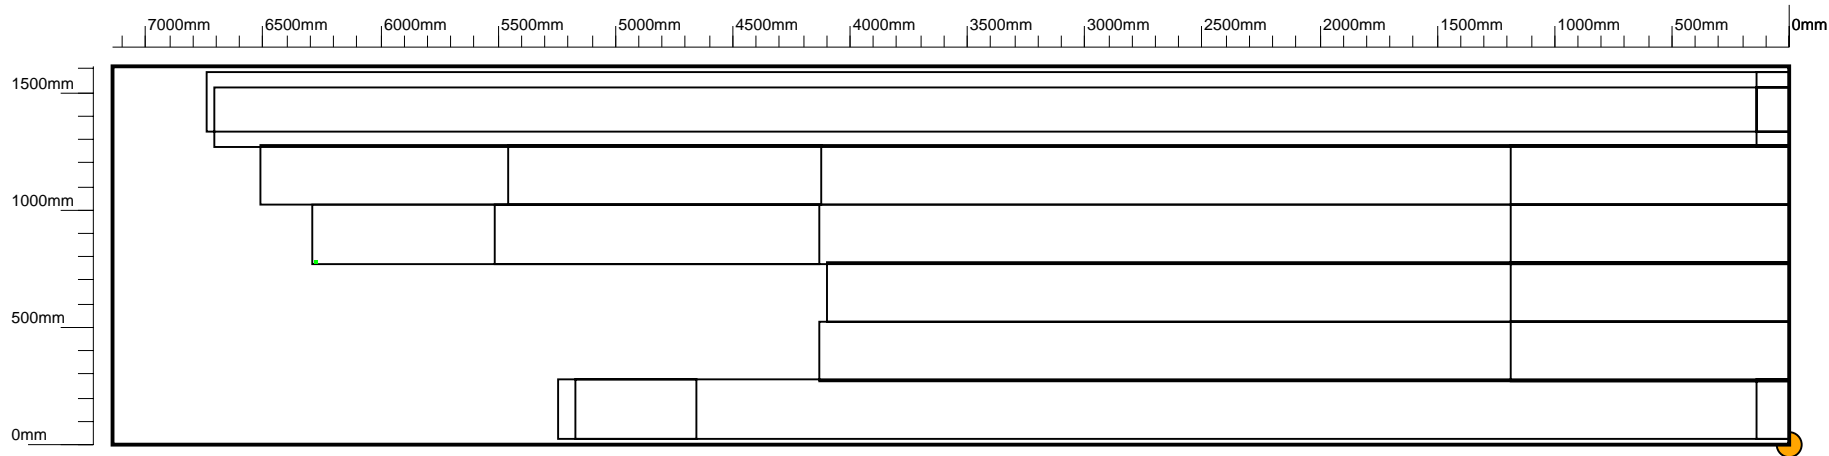
**Row:** 22  
**Plate Length:** 7140  
**Orientation:** Horizontal  
**Max discontinuity:** 40  
**Lower Threshold:** 40

**Plate:** 1  
**Plate Width:** 1610  
**Scan Method:** Uni-Directional  
**Discontinuity Count:** 1  
**Upper Threshold:** 100      **Import Threshold:** 20%

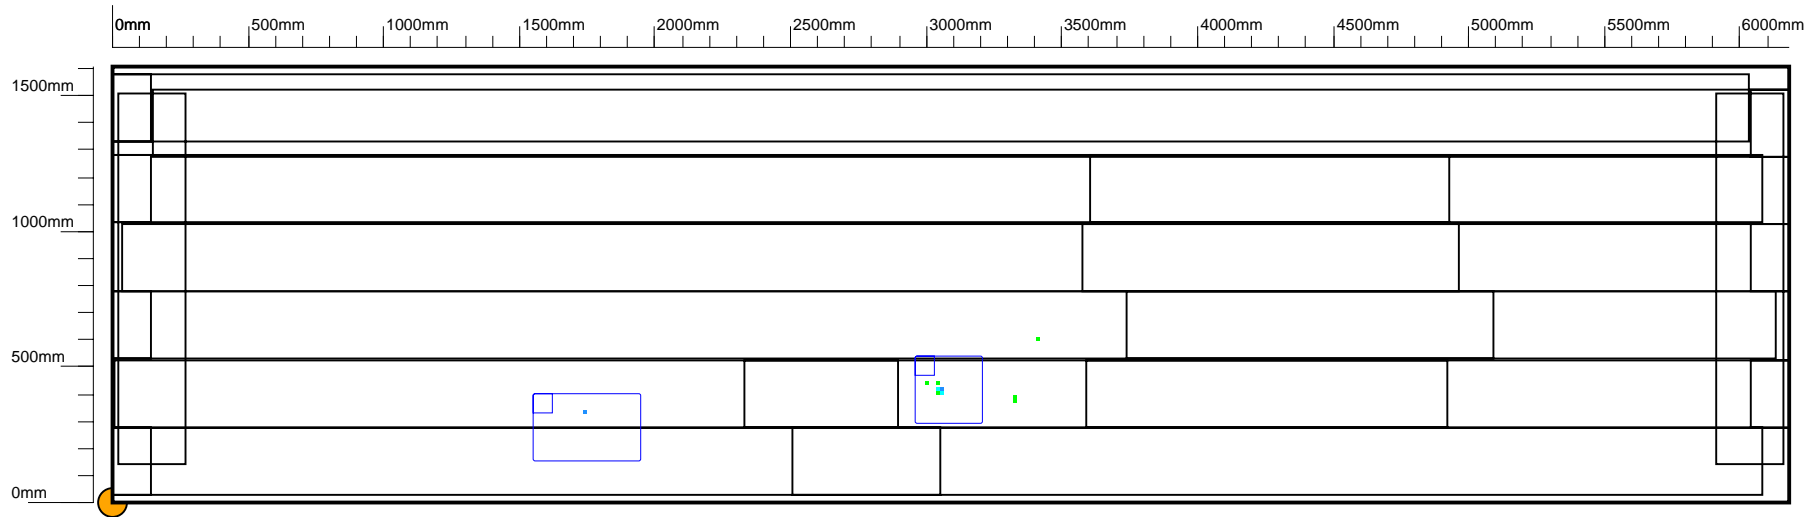
**Row:** 22  
**Plate Length:** 6180  
**Orientation:** Horizontal  
**Max discontinuity:** 64  
**Lower Threshold:** 40

**Plate:** 2  
**Plate Width:** 1610  
**Scan Method:** Raster  
**Discontinuity Count:** 10  
**Upper Threshold:** 100

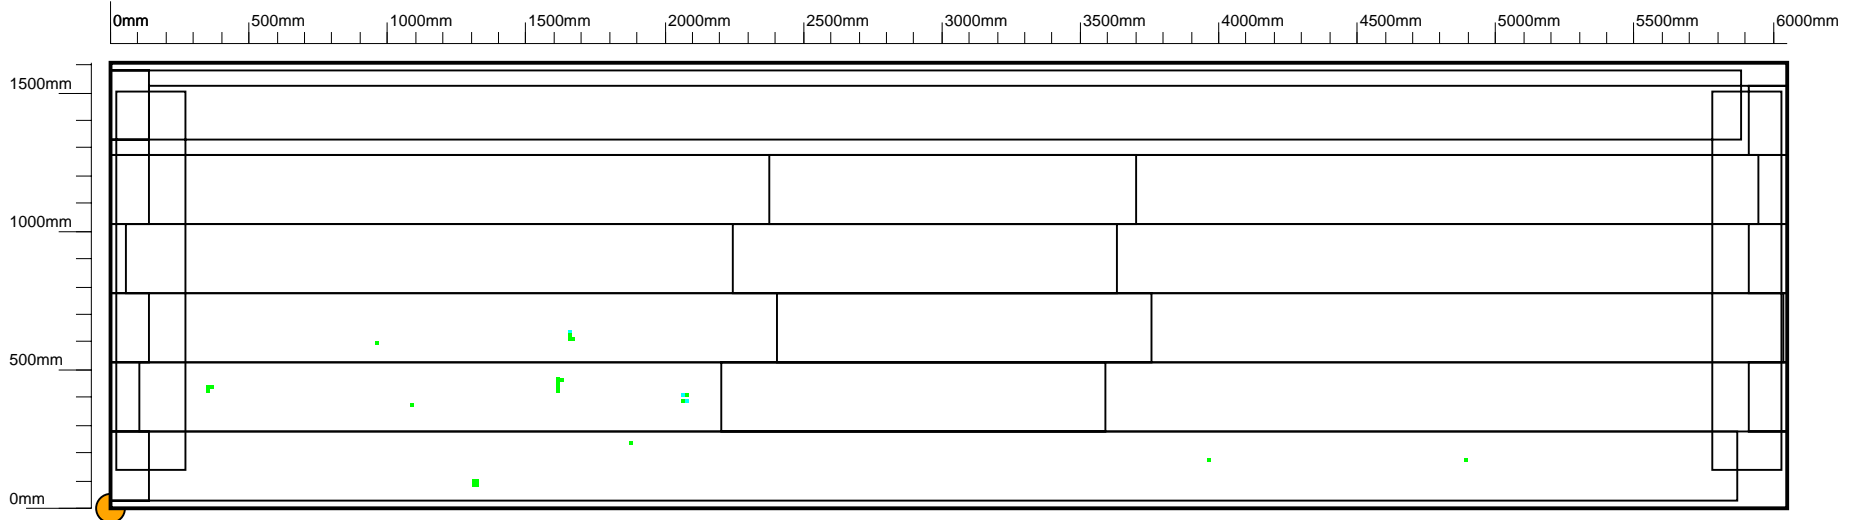
**Row:** 22  
**Plate Length:** 6050  
**Orientation:** Horizontal  
**Max discontinuity:** 51  
**Lower Threshold:** 40

**Plate:** 3  
**Plate Width:** 1610  
**Scan Method:** Raster  
**Discontinuity Count:** 25  
**Upper Threshold:** 100

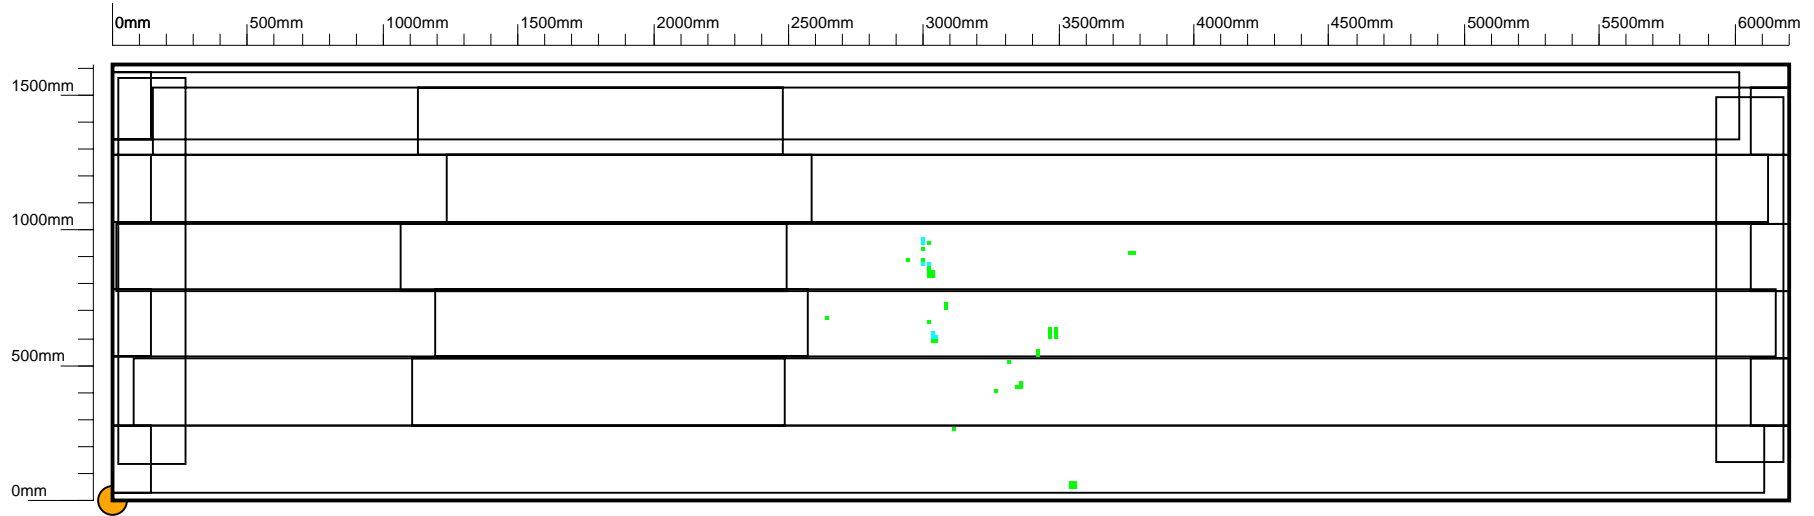
**Row:** 22  
**Plate Length:** 6200  
**Orientation:** Horizontal  
**Max discontinuity:** 54  
**Lower Threshold:** 40

**Plate:** 4  
**Plate Width:** 1610  
**Scan Method:** Raster  
**Discontinuity Count:** 42  
**Upper Threshold:** 100

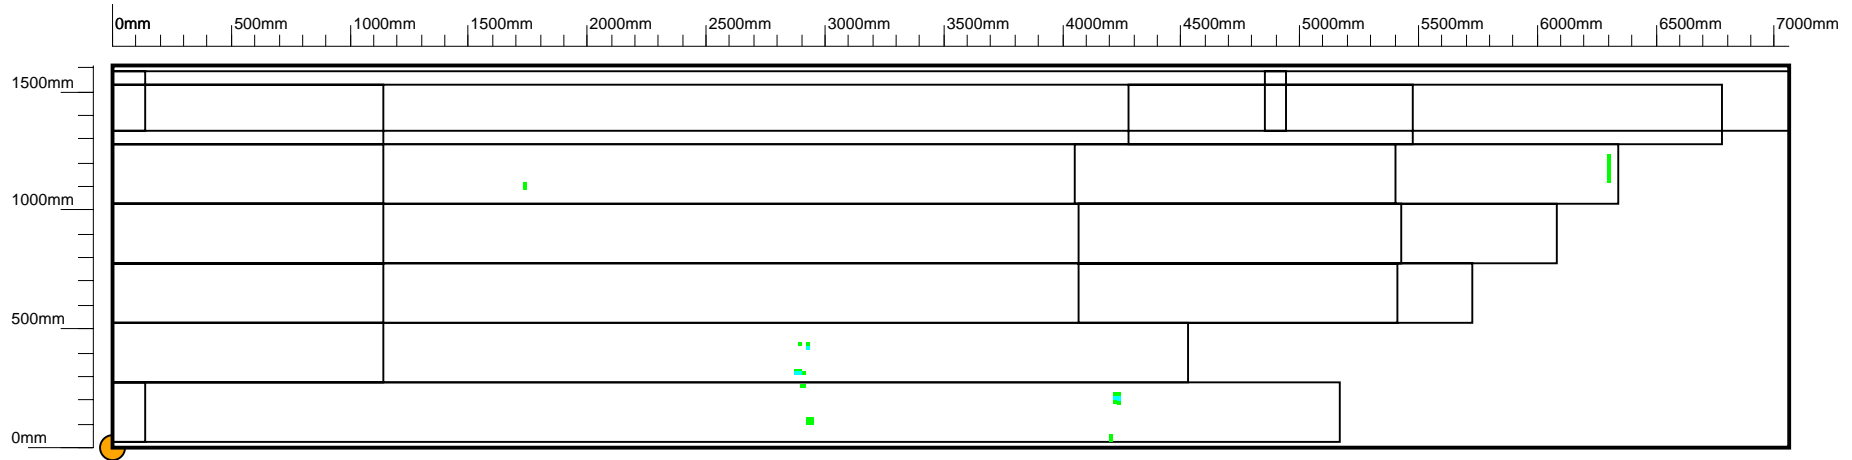
**Row:** 22  
**Plate Length:** 7060  
**Orientation:** Horizontal  
**Max discontinuity:** 56  
**Lower Threshold:** 40

**Plate:** 5  
**Plate Width:** 1610  
**Scan Method:** Uni-Directional  
**Discontinuity Count:** 33  
**Upper Threshold:** 100      **Import Threshold:** 20%

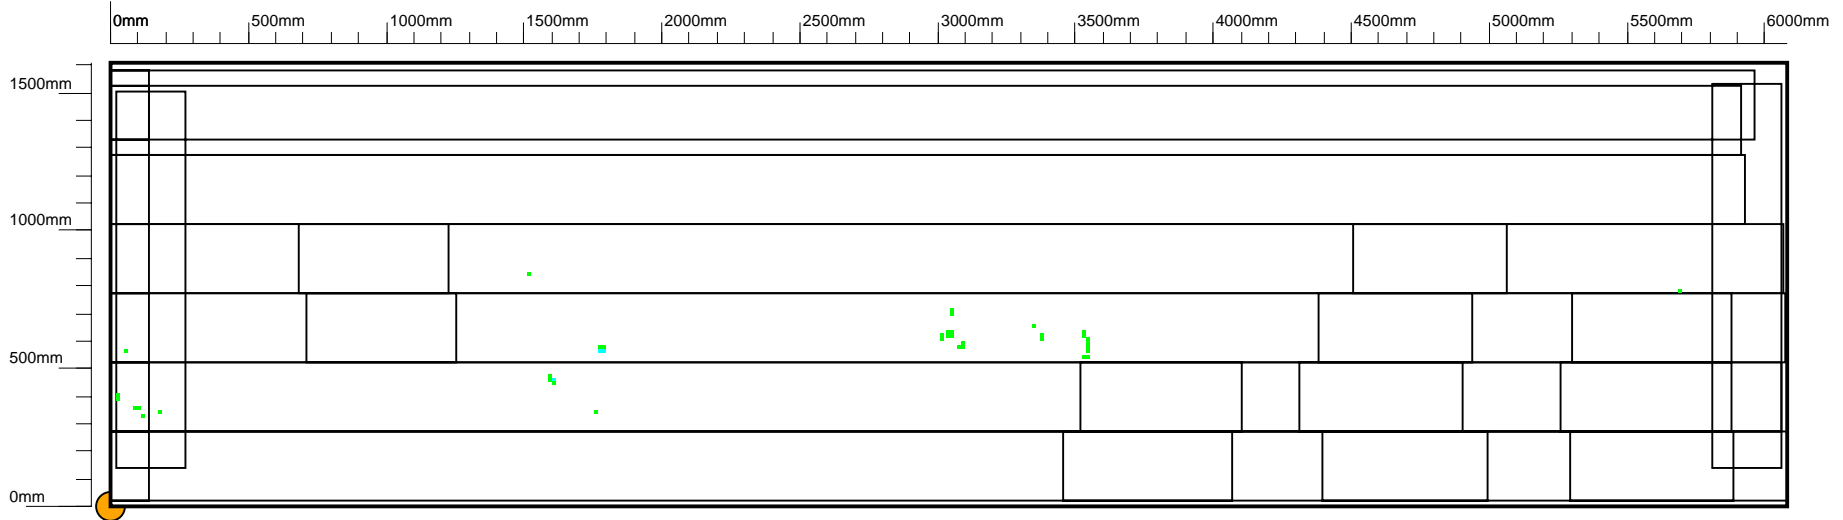
**Row:** 23  
**Plate Length:** 6080  
**Orientation:** Horizontal  
**Max discontinuity:** 51  
**Lower Threshold:** 40

**Plate:** 2  
**Plate Width:** 1610  
**Scan Method:** Uni-Directional  
**Discontinuity Count:** 40  
**Upper Threshold:** 100      **Import Threshold:** 20%

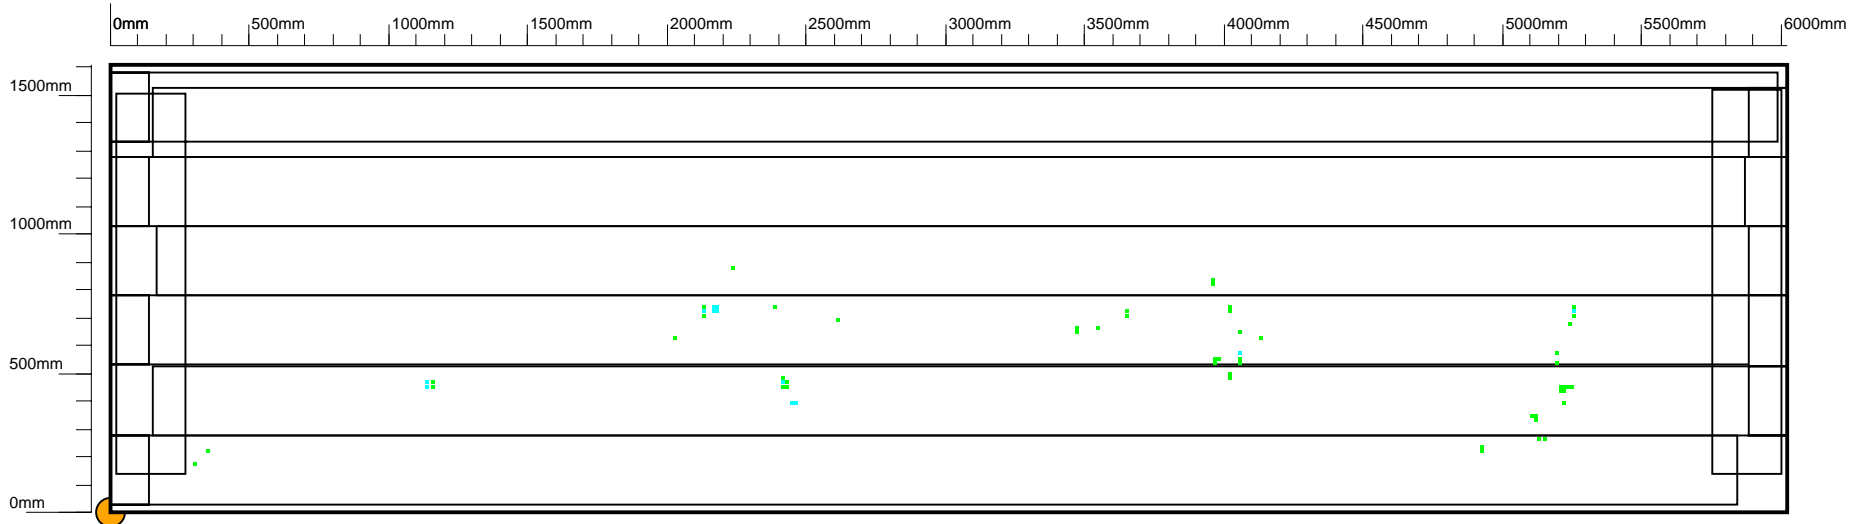
**Row:** 23  
**Plate Length:** 6020  
**Orientation:** Horizontal  
**Max discontinuity:** 57  
**Lower Threshold:** 40

**Plate:** 3  
**Plate Width:** 1610  
**Scan Method:** Raster  
**Discontinuity Count:** 63  
**Upper Threshold:** 100

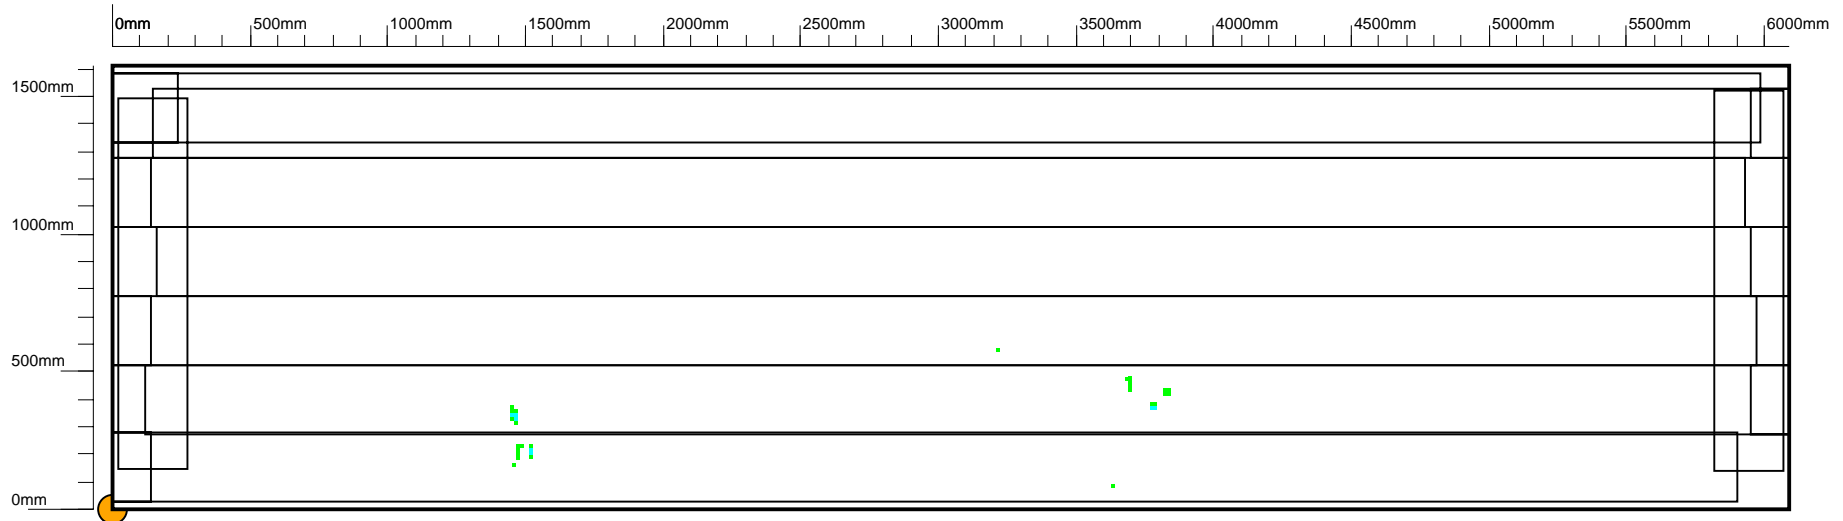
**Row:** 23  
**Plate Length:** 6090  
**Orientation:** Horizontal  
**Max discontinuity:** 57  
**Lower Threshold:** 40

**Plate:** 4  
**Plate Width:** 1610  
**Scan Method:** Raster  
**Discontinuity Count:** 33  
**Upper Threshold:** 100

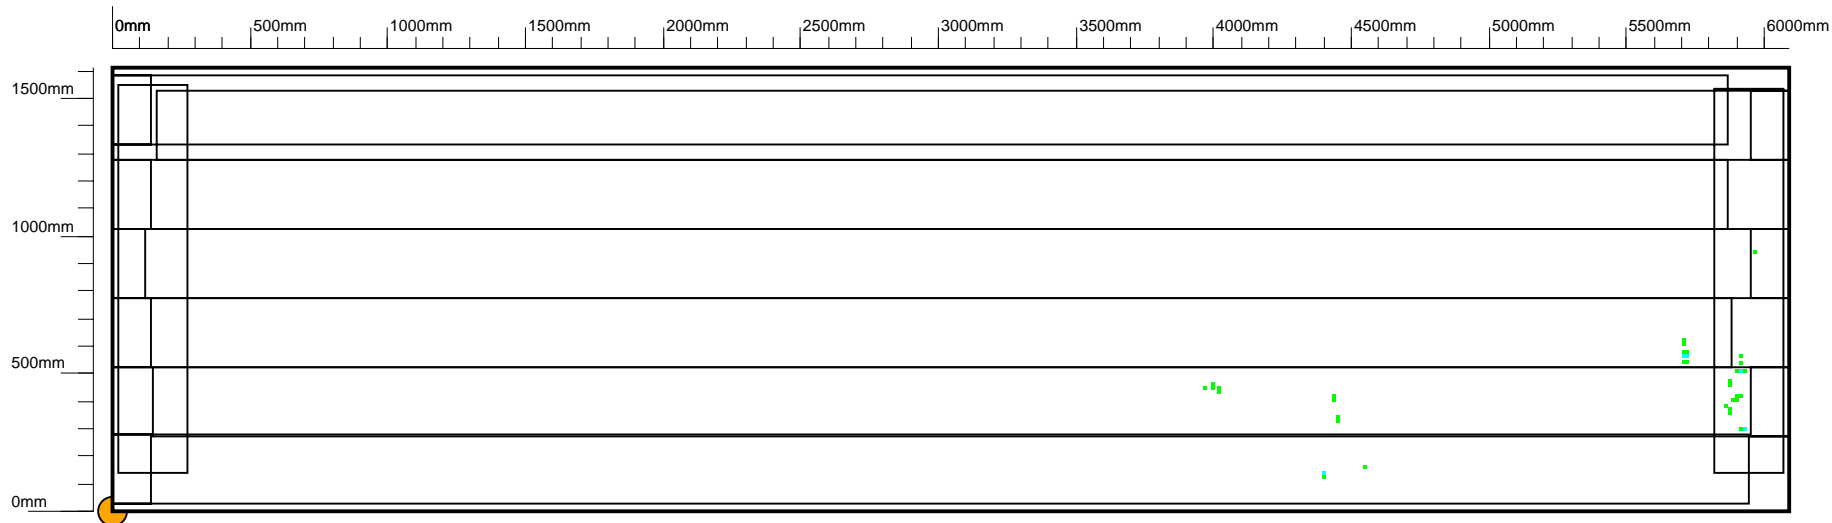
**Row:** 23  
**Plate Length:** 6090  
**Orientation:** Horizontal  
**Max discontinuity:** 57  
**Lower Threshold:** 40

**Plate:** 5  
**Plate Width:** 1610  
**Scan Method:** Raster  
**Discontinuity Count:** 37  
**Upper Threshold:** 100

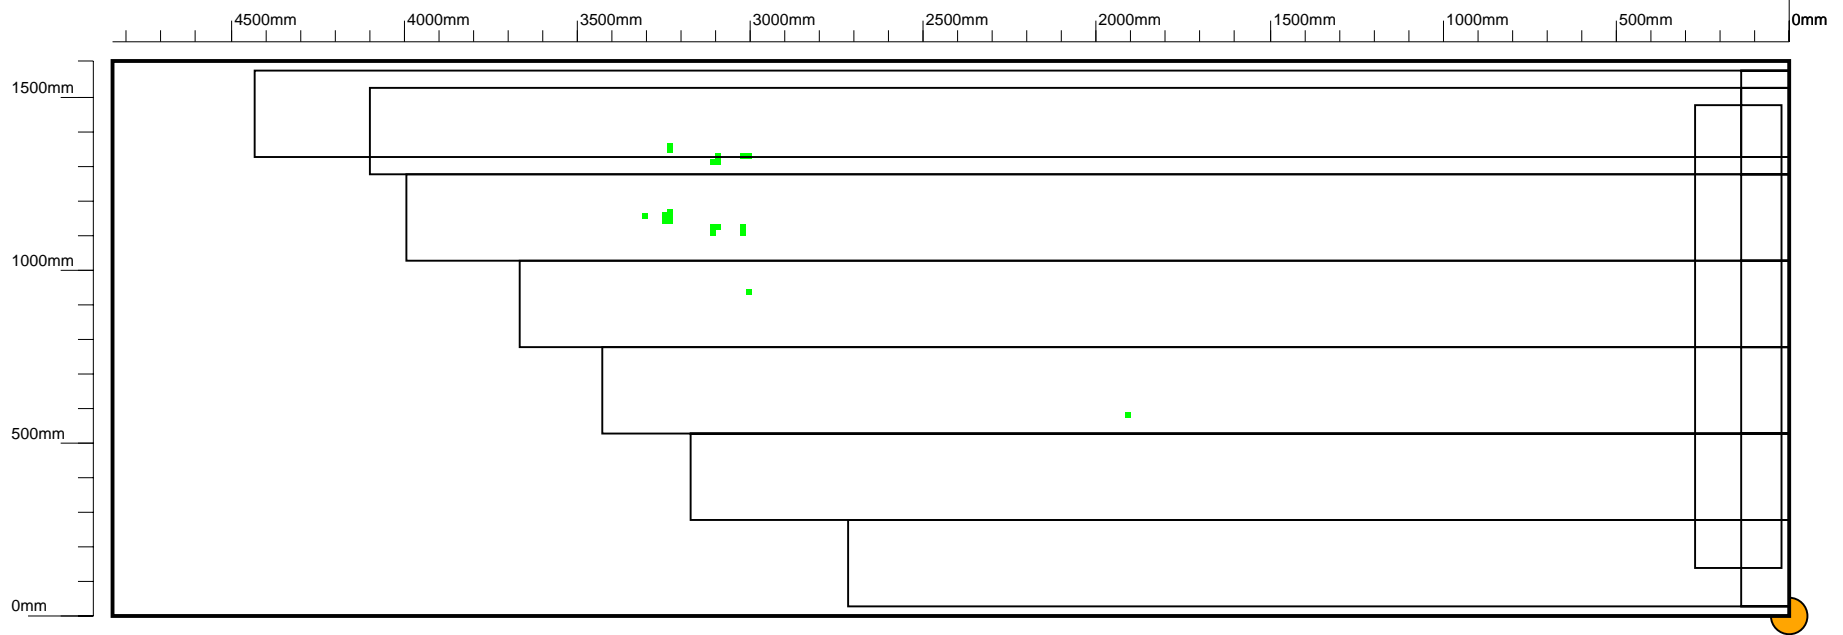
**Row:** 24  
**Plate Length:** 4840  
**Orientation:** Horizontal  
**Max discontinuity:** 48  
**Lower Threshold:** 40

**Plate:** 1  
**Plate Width:** 1600  
**Scan Method:** Uni-Directional  
**Discontinuity Count:** 20  
**Upper Threshold:** 100      **Import Threshold:** 20%

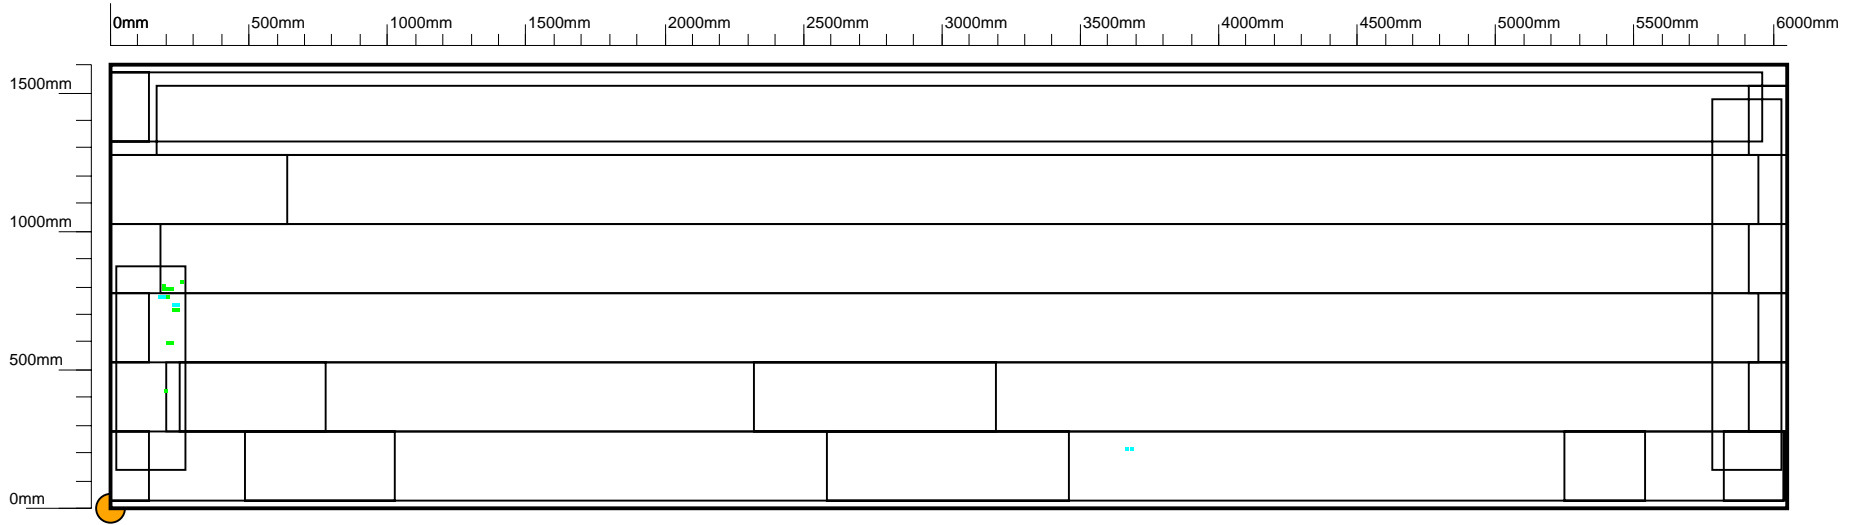
**Row:** 24  
**Plate Length:** 6050  
**Orientation:** Horizontal  
**Max discontinuity:** 59  
**Lower Threshold:** 40

**Plate:** 2  
**Plate Width:** 1600  
**Scan Method:** Raster  
**Discontinuity Count:** 17  
**Upper Threshold:** 100

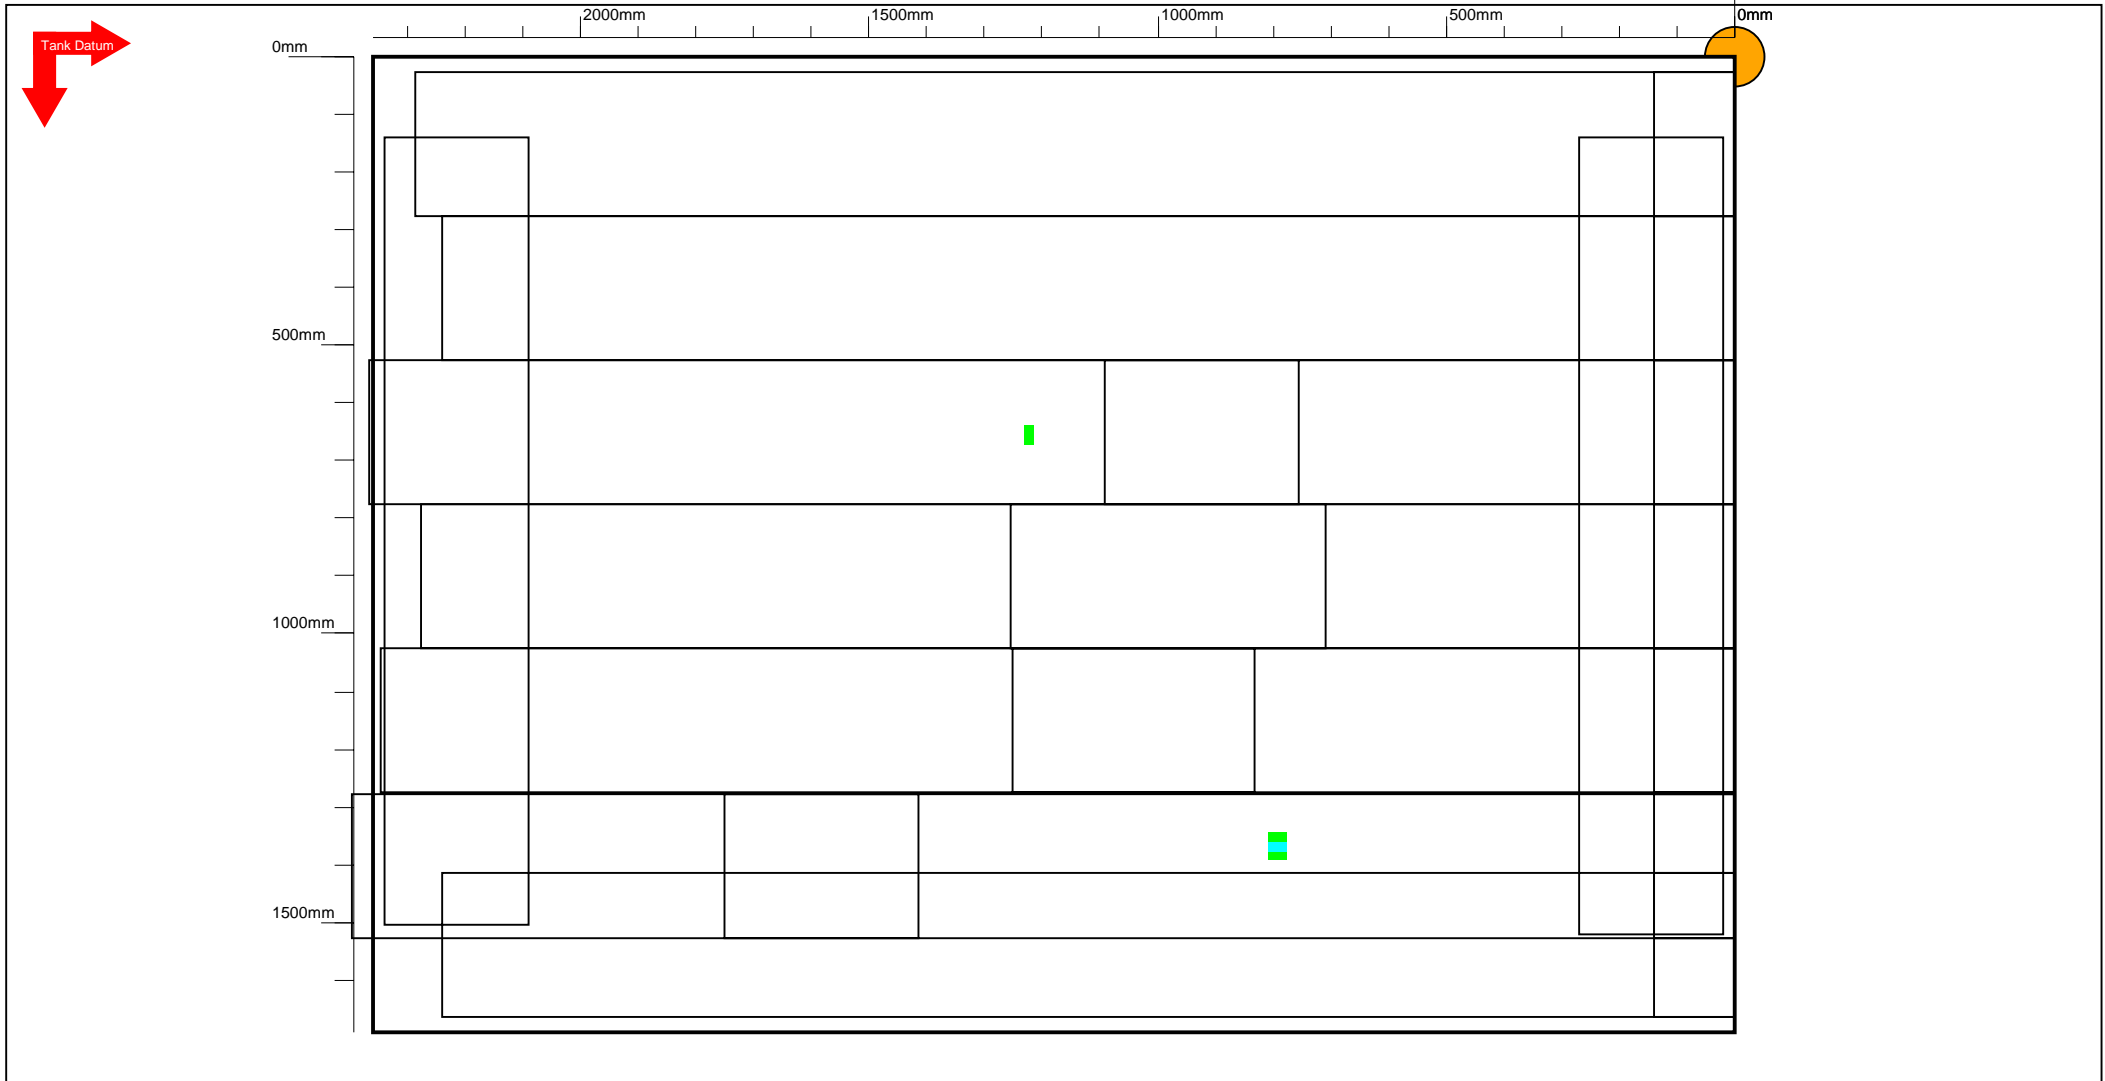
<b>Row:</b> 25 <b>Plate Length:</b> 2360 <b>Orientation:</b> Vertical <b>Max discontinuity:</b> 50 <b>Lower Threshold:</b> 40	<b>Plate:</b> 6 <b>Plate Width:</b> 1690 <b>Scan Method:</b> Uni-Directional <b>Discontinuity Count:</b> 8 <b>Upper Threshold:</b> 100	<b>Import Threshold:</b> 20%
	<b>Tank:</b> 8 <b>Location:</b> Sample <b>Company:</b> Silverwing uk ltd <b>Client:</b> Sample <b>Date:</b> 1/13/2006

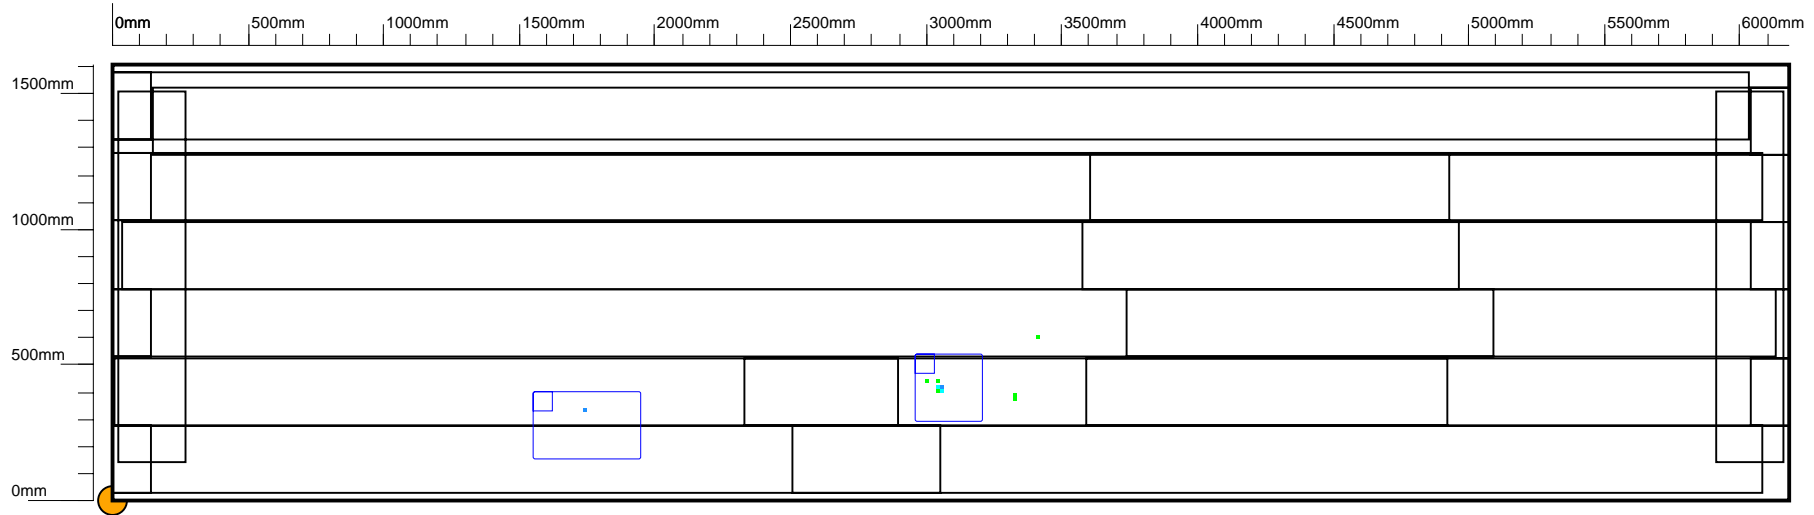
**Row:** 22  
**Plate Length:** 6180  
**Orientation:** Horizontal  
**Max discontinuity:** 64  
**Lower Threshold:** 40

**Plate:** 2  
**Plate Width:** 1610  
**Scan Method:** Raster  
**Discontinuity Count:** 10  
**Upper Threshold:** 100

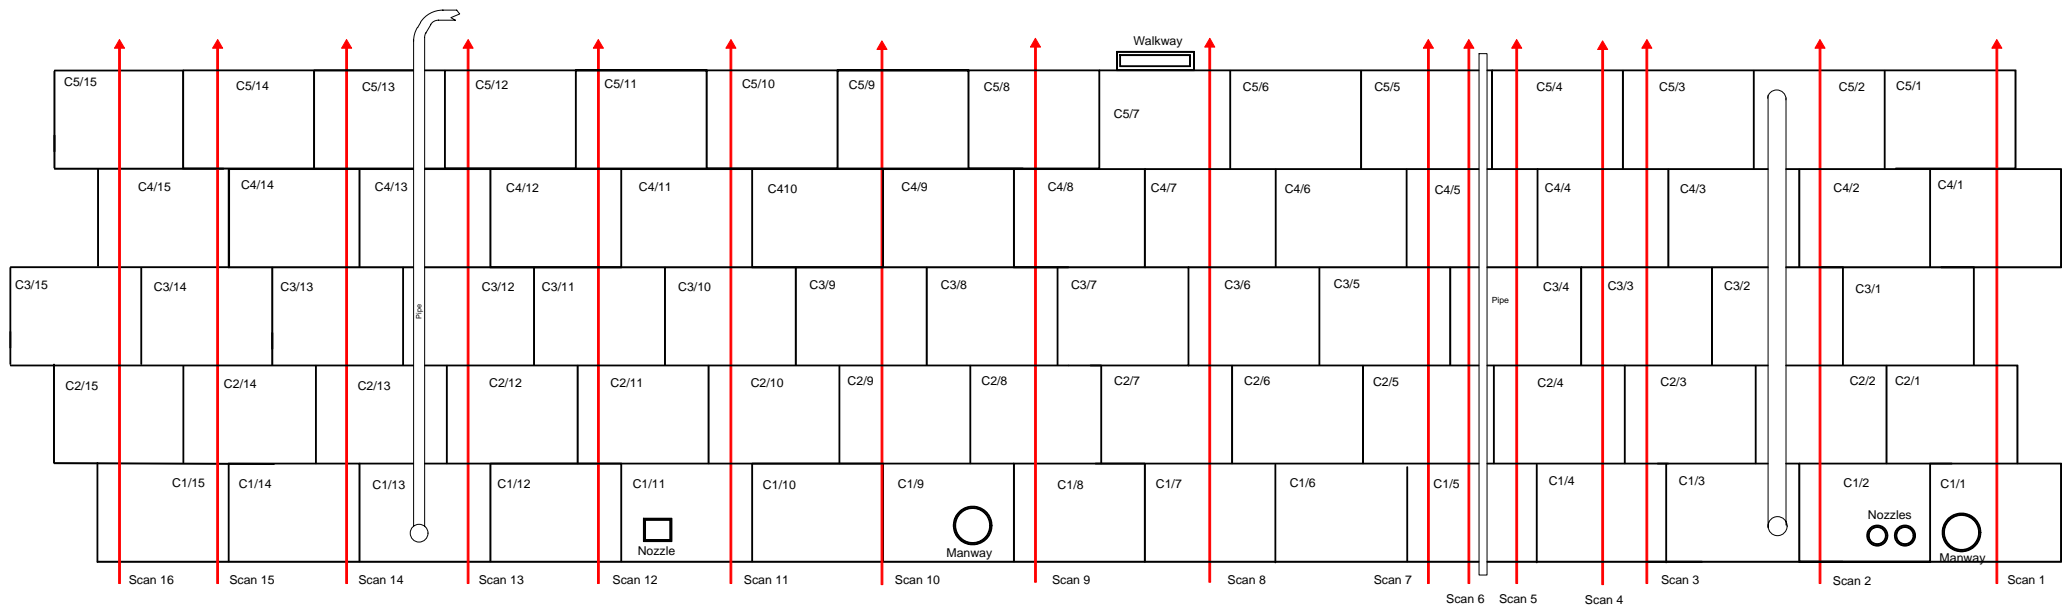
**B Scan Survey**  
**Tank shell layout & B-scan positions**

Course 1, (12mm N.P.T)  
 Course 2, (10mm N.P.T)  
 Course 3, (8mm N.P.T)  
 Course 4, (6mm N.P.T)  
 Course 5, (6mm N.P.T)

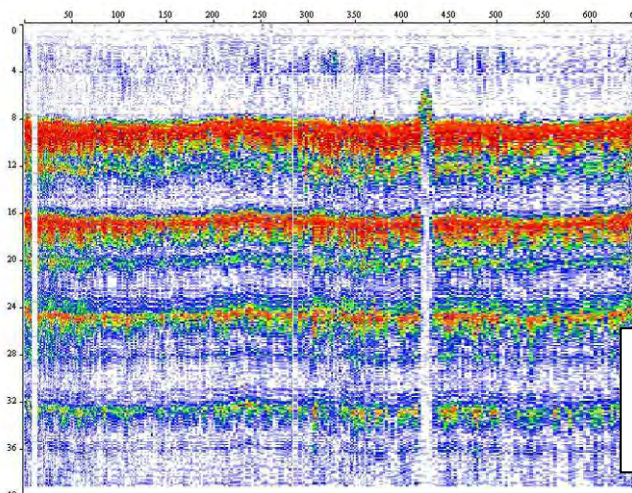
Figure 2  
Example of small diameter  
isolated corrosion pit

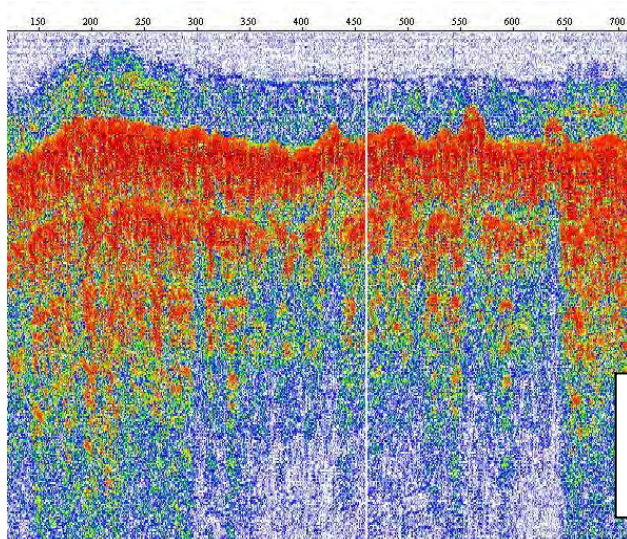
Figure 3  
Example of severe corrosion  
pitting over a large area
